Storm Drain Condition Assessment Reports

Memorandum

Date: July 2, 2019
From: Marliese von Huene, P.E. & Joey Hegna, P.E. – CRW Engineering Group, LLC
Project: 48th Avenue and Cordova Street Reconstruction
Project No: PM&E# 06-26 (CRW# 10143.00)
Subject: CCTV Storm Drain Condition Assessment

Date: July 2, 2019
From: Marliese von Huene, P.E. & Joey Hegna, P.E. – CRW Engineering Group, LLC
Project: 48th Avenue and Cordova Street Reconstruction
Project No: PM&E# 06-26 (CRW# 10143.00)
Subject: Storm Drain Manhole Condition Assessment

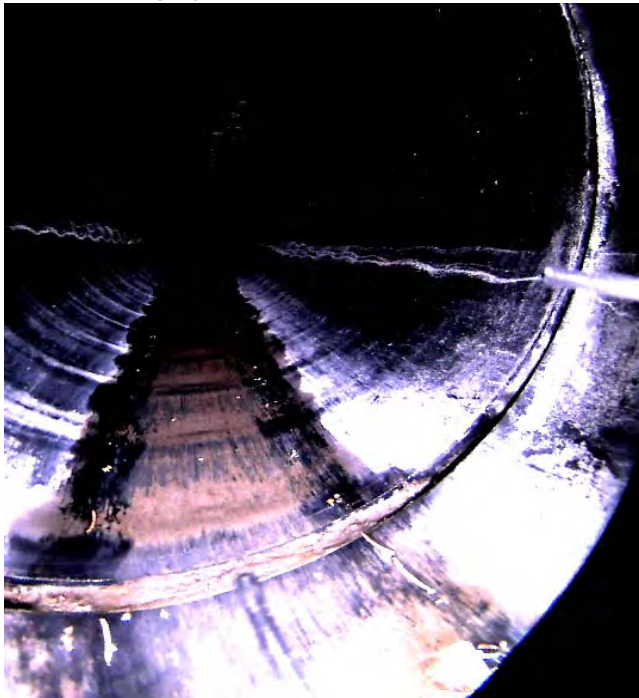
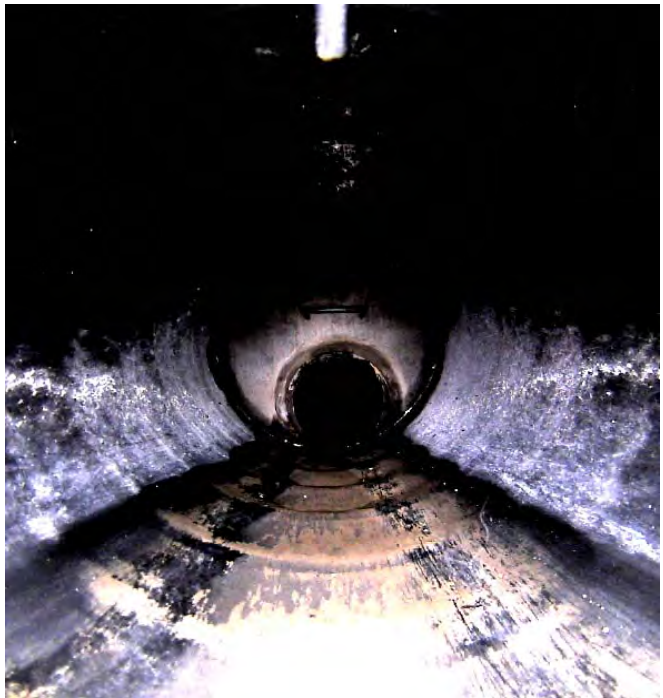
48th Avenue & Cordova Street Reconstruction CCTV #12033 - Cordova Street, near 48th Avenue intersection

Other Notes: Pipe appears to be in good condition, minor joint offset

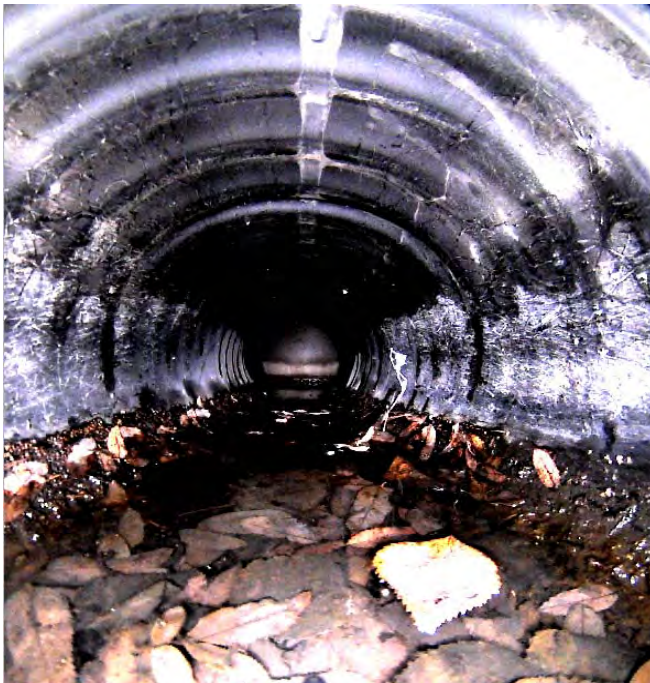
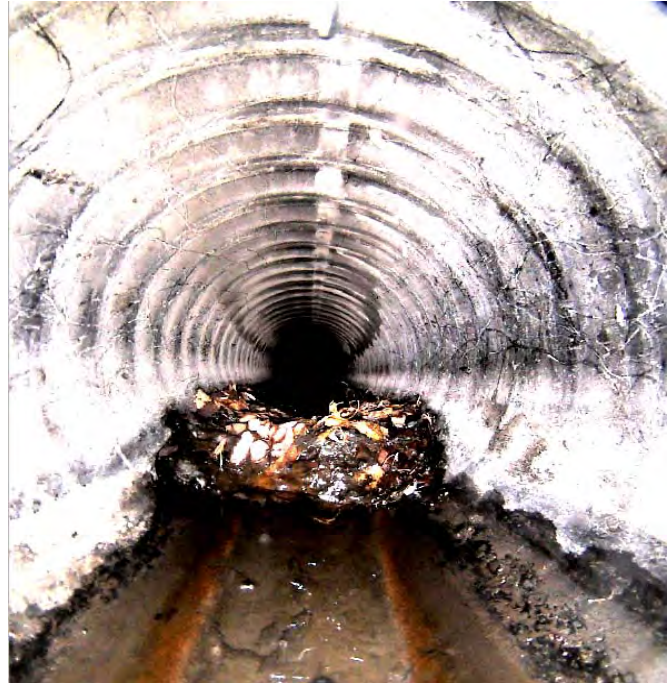
48th Avenue & Cordova Street Reconstruction CCTV #14303 - 48th Avenue, near Cordova Street intersection

Debris Present? Significant leaf buildup

Other Notes: Pipe appears to be in good condition, but leaf buildup is restricting flow. Looks like some root intrusion is possible along walls.

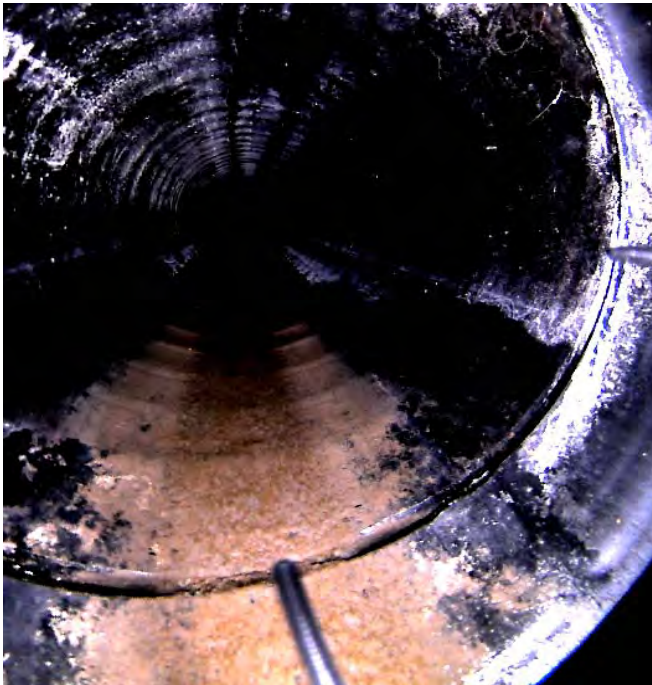
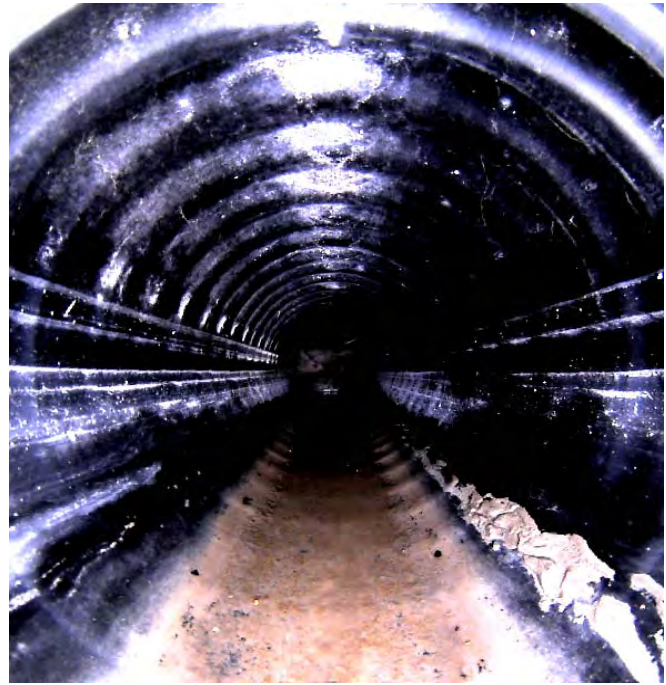
48th Avenue & Cordova Street Reconstruction CCTV #22397 - 48th Avenue, near Cordova Street intersection

Other Notes: Pipe appears to be in good condition, minor joint offset

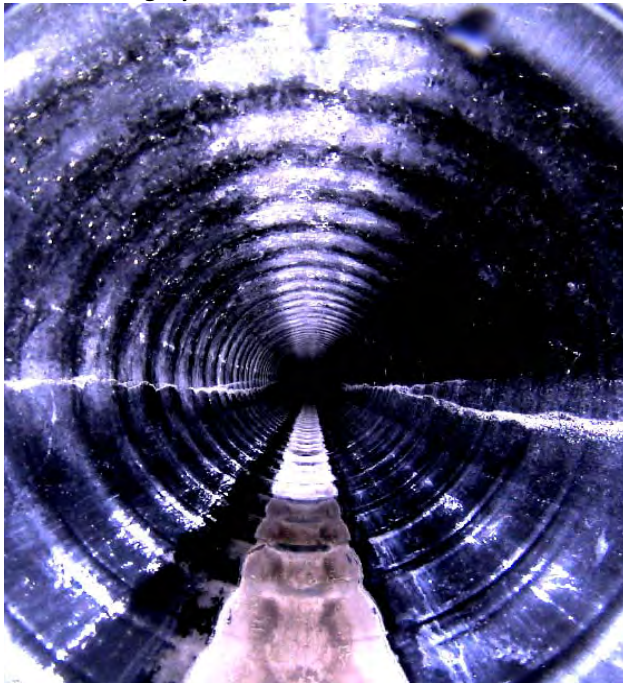
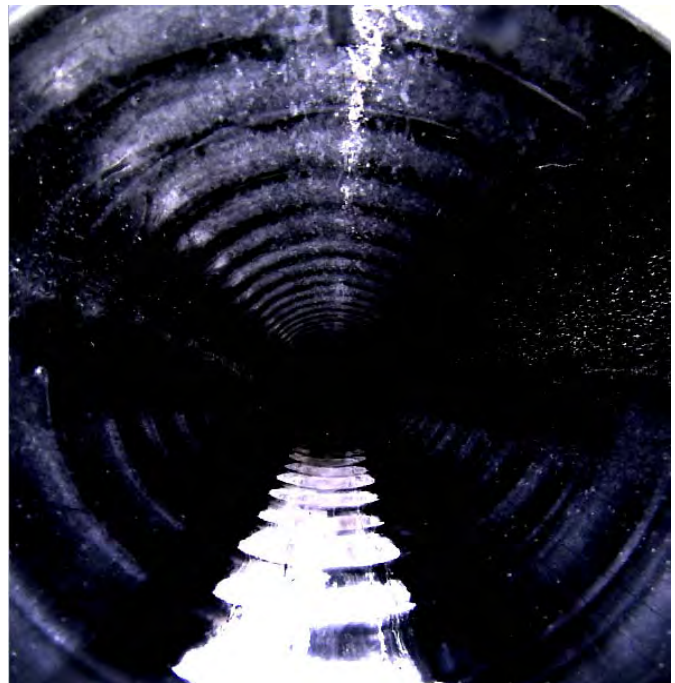
48th Avenue & Cordova Street Reconstruction CCTV #39158 - Cordova Street, near 48th Avenue intersection

Other Notes: Pipe appears to be in good condition

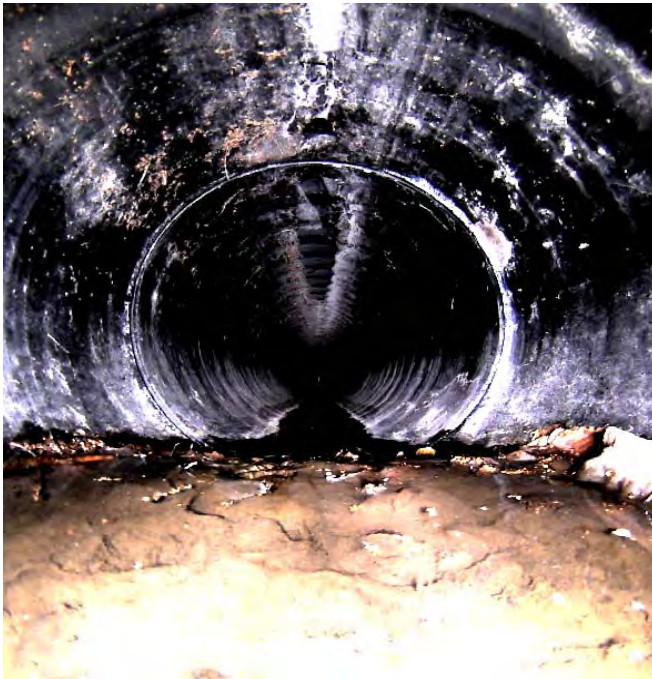
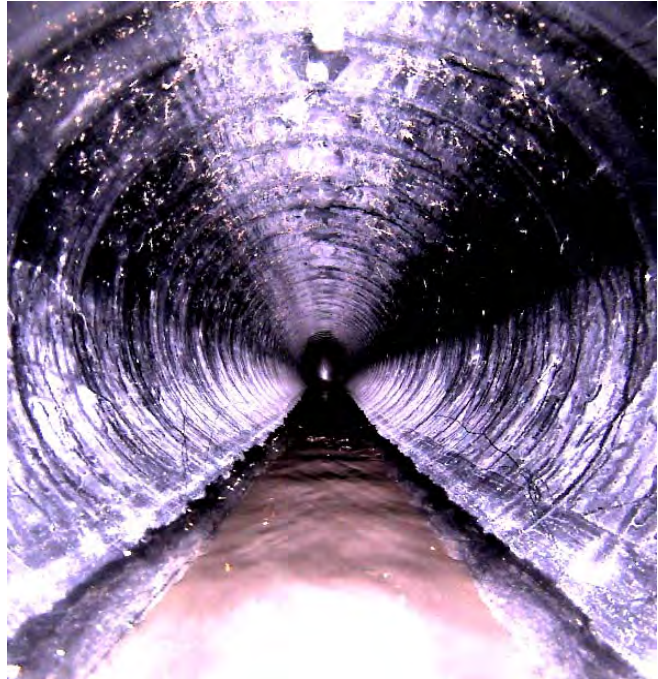
48th Avenue & Cordova Street Reconstruction CCTV #39159 - 48th Avenue, near Cordova Street intersection

Debris Present? Significant leaf buildup

Other Notes: Pipe appears to be in good condition, but leaf buildup is restricting flow.

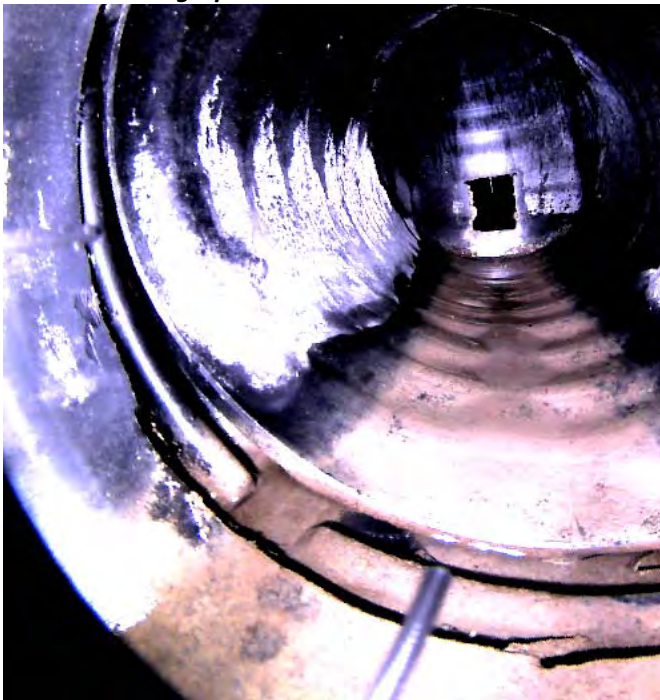
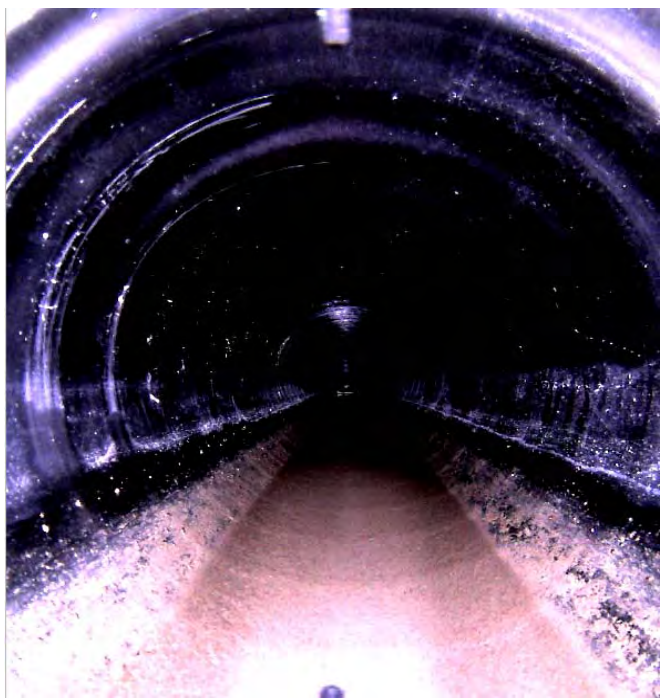
48th Avenue & Cordova Street Reconstruction CCTV #39160 - 48th Avenue, near Cordova Street intersection

Other Notes: Pipe appears to be in good condition, one joint offset

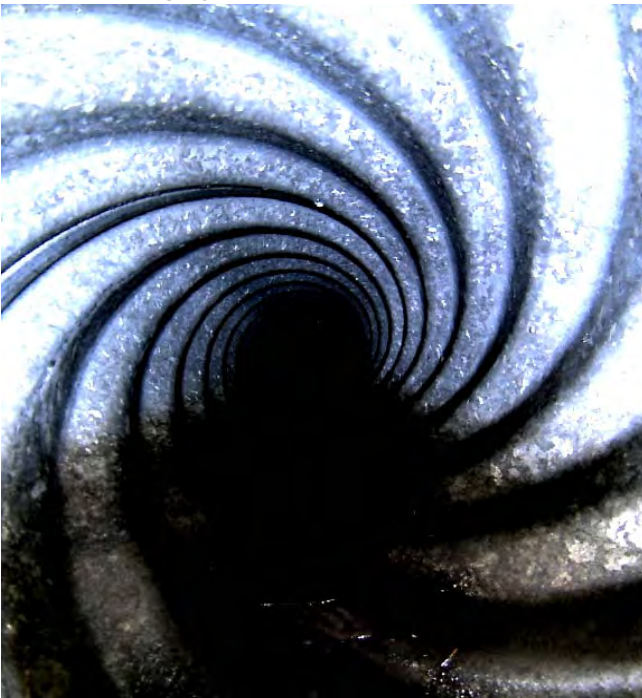
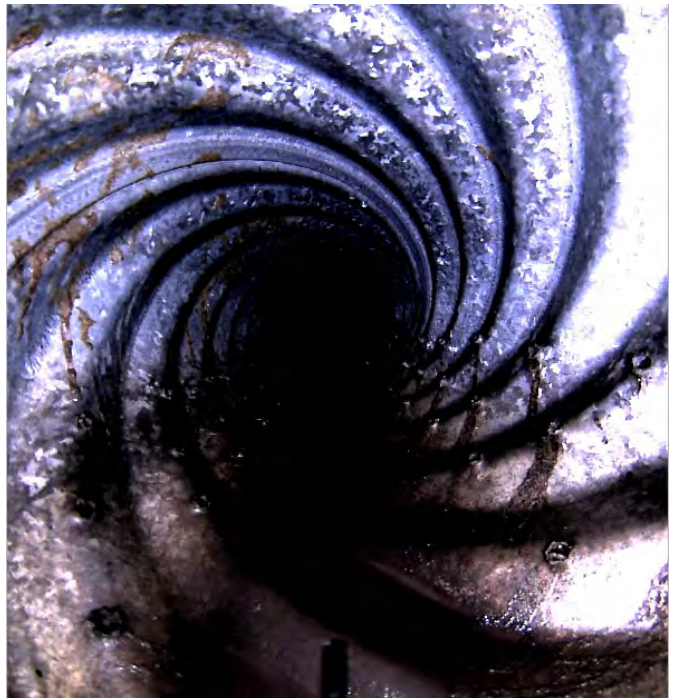
48th Avenue & Cordova Street Reconstruction CCTV #25910 - 48th Avenue, near Eagle Street intersection

Other Notes: Pipe appears to be in good condition, but lighting made it difficult to see the bottom half of the pipe.

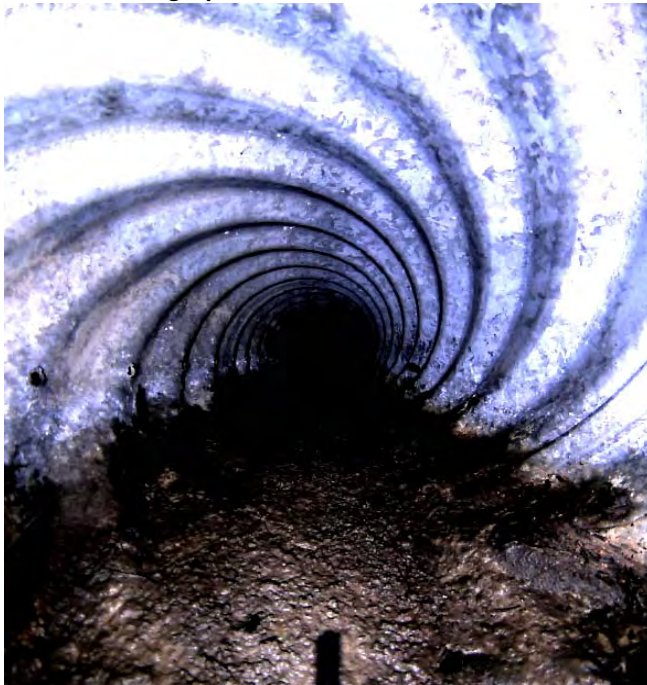
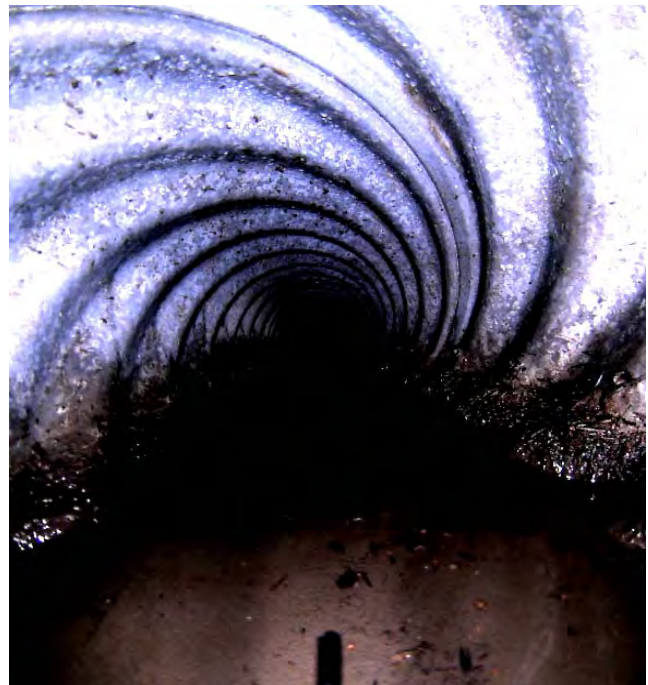
48th Avenue & Cordova Street Reconstruction CCTV #29685 - 48th Avenue, near Eagle Street intersection

Debris Present? Significant debris buildup

Other Notes: Visible pipe appears to be in good condition, but significant buildup is restricting and backing up flow.

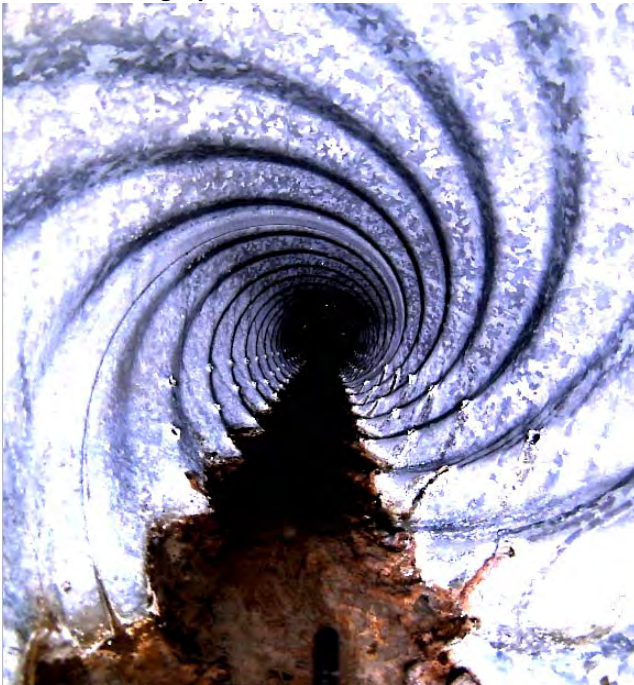
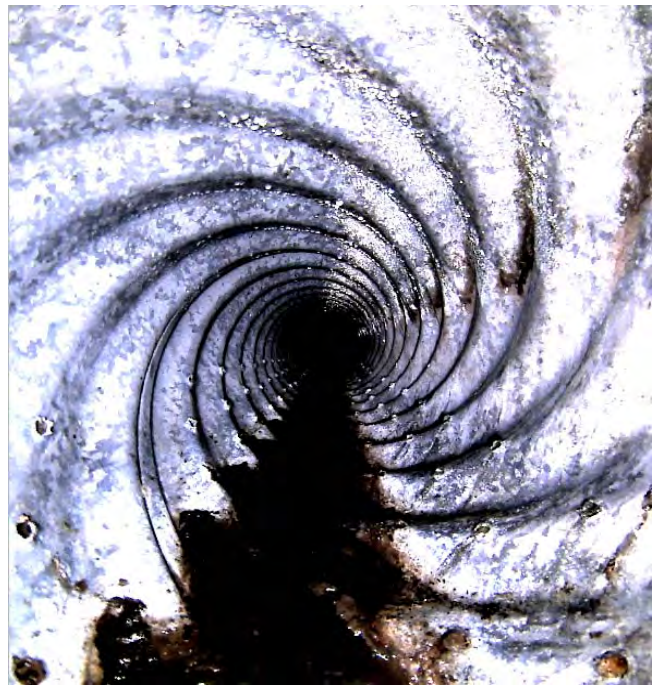
48th Avenue & Cordova Street Reconstruction CCTV #32710 - Denali Street, near 48th Avenue intersection

Other Notes: Pipe appears to be in good condition

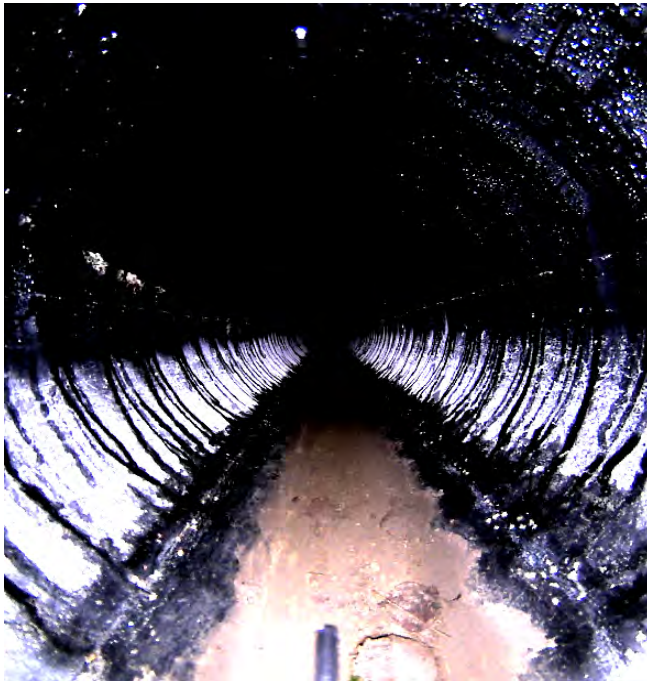
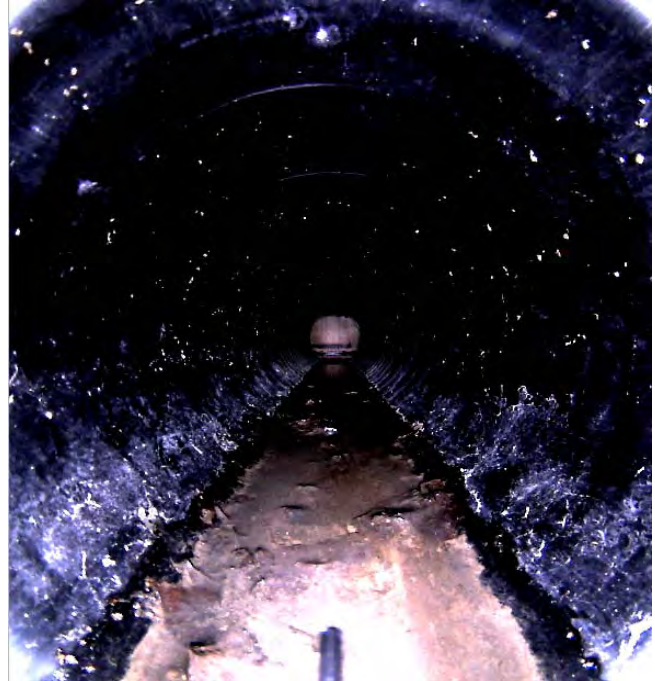
48th Avenue & Cordova Street Reconstruction CCTV #34751 - Eagle Street, near 48th Avenue intersection

Other Notes: Pipe appears to be in good condition

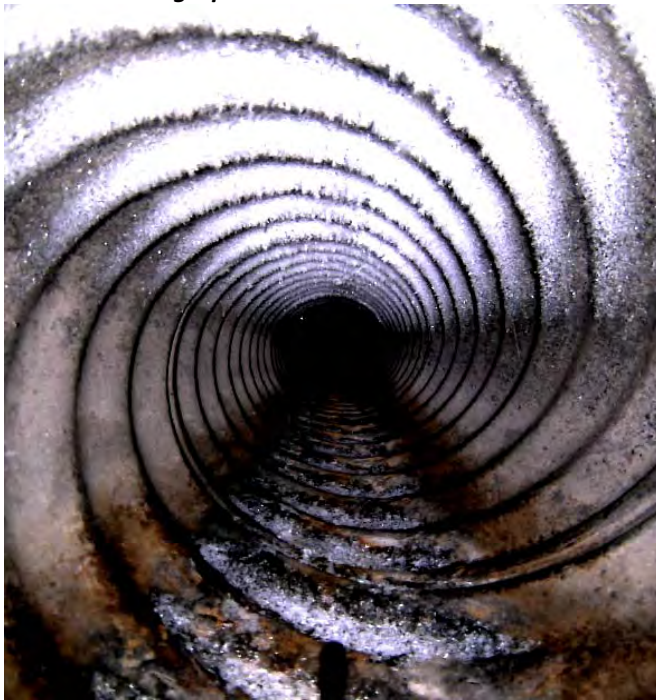
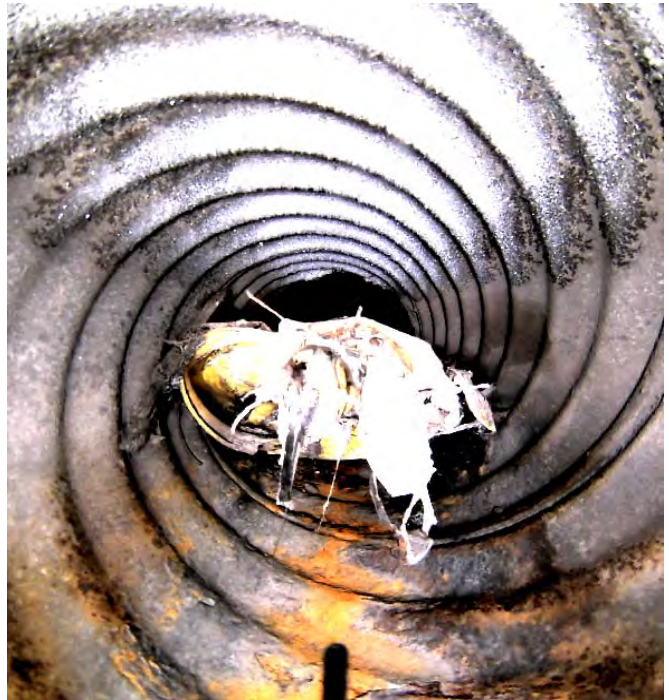
48th Avenue & Cordova Street Reconstruction CCTV #12998 - Old Seward Highway, near 48th Avenue intersection

Other Notes: Large debris in pipe will block high flows. Pipe appears to be close to surface - significant freezing seen on pipe top. Invert rusted in most of length.

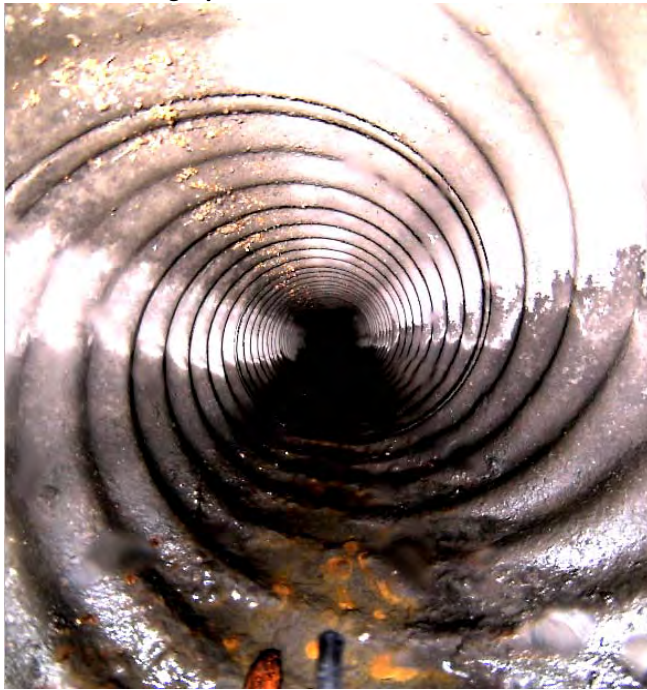
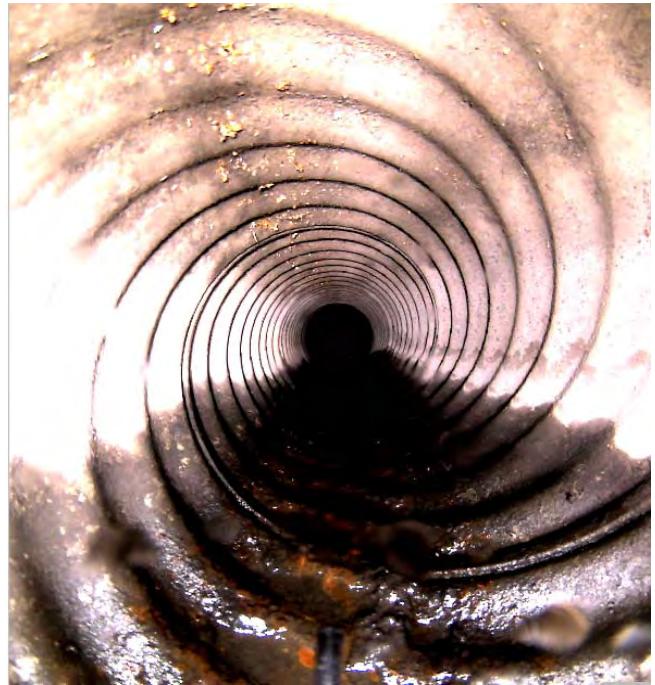
48th Avenue & Cordova Street Reconstruction CCTV #15553 - 48th Avenue, near Old Seward Highway intersection

Other Notes: Pipe has small patches of rusting and small amount of debris buildup along invert.

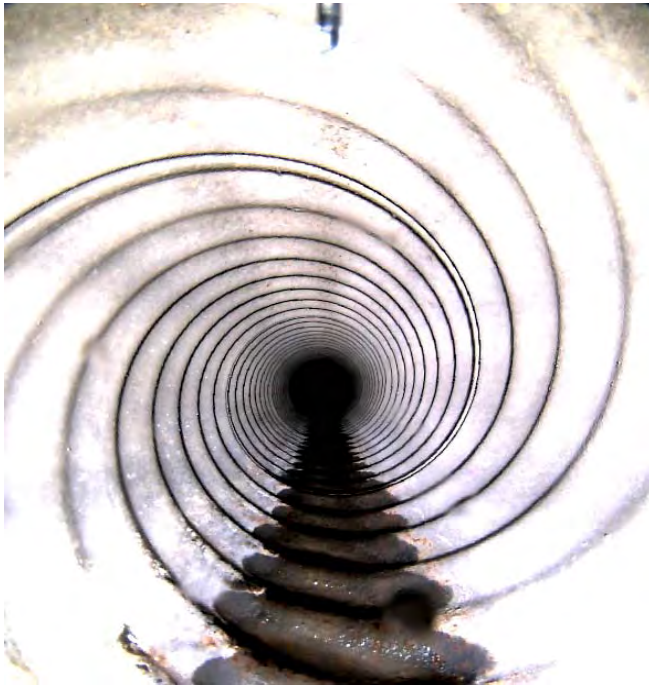
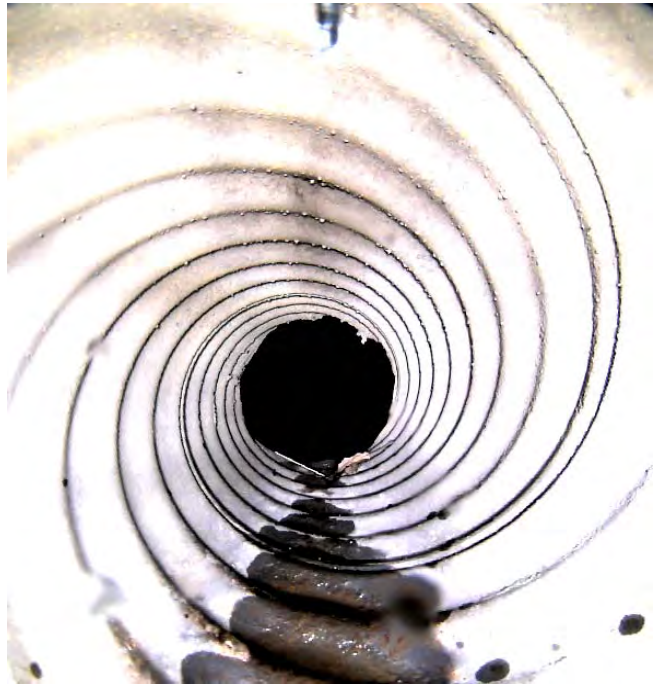
48th Avenue & Cordova Street Reconstruction CCTV
#16178 - 48th Avenue, near Old Seward Highway intersection

Other Notes: Pipe has small patches of rusting and small amount of debris buildup along invert.

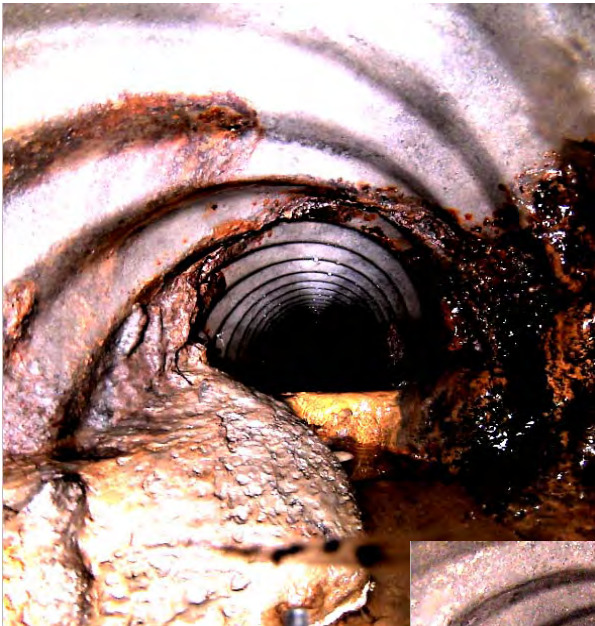
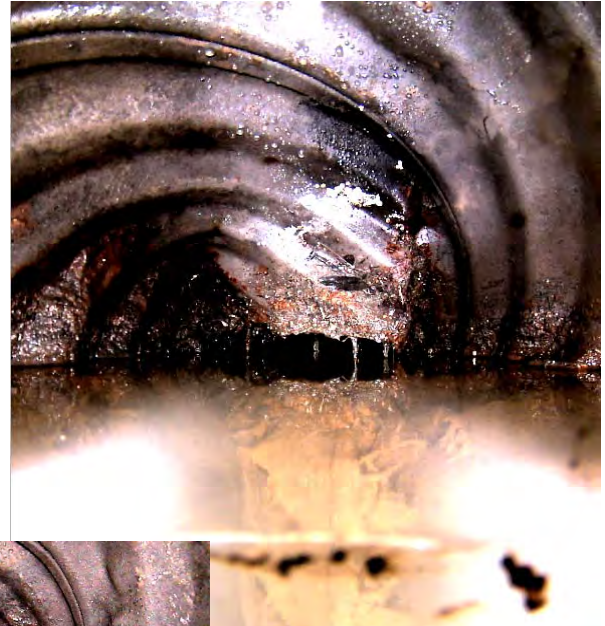
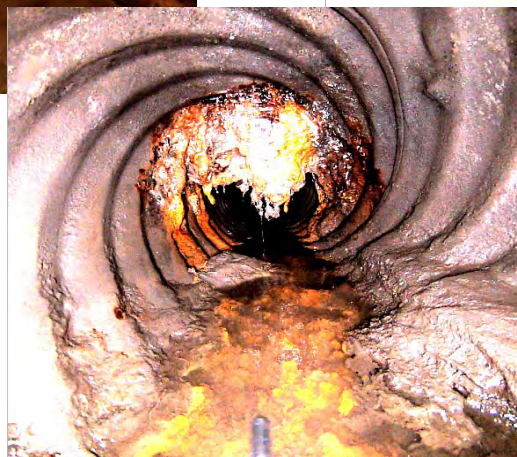
48th Avenue & Cordova Street Reconstruction CCTV #16710 - 48th Avenue, near Gambell Street intersection

Other Notes: Pipe has a large break that prevented the CCTV camera from proceeding for full length (second video started from other side, but still missing around 70 feet of middle pipe length). Large debris in pipe dams flow in a few locations. Invert rusted through and missing for most of visible length.

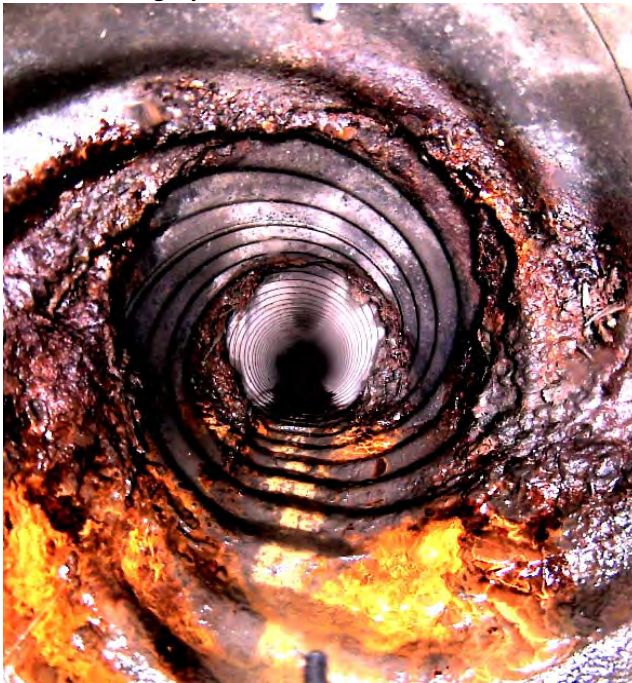
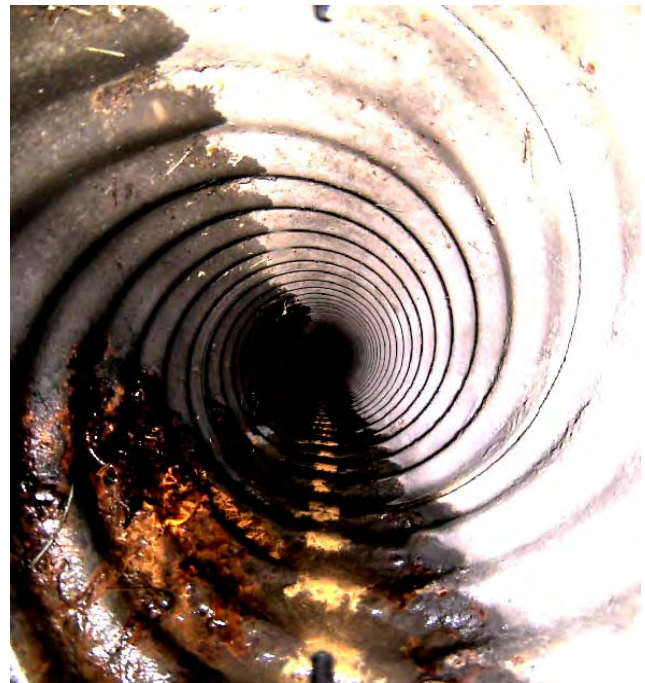
48th Avenue & Cordova Street Reconstruction CCTV #17134 - 48th Avenue and Gambell Street intersection

Debris Present? Minor/moderate infiltration buildup

Other Notes: Pipe is mostly in good condition, except for one significant infiltration section (about 2-3 feet long) and multiple smaller rust/infiltration spots nearby.

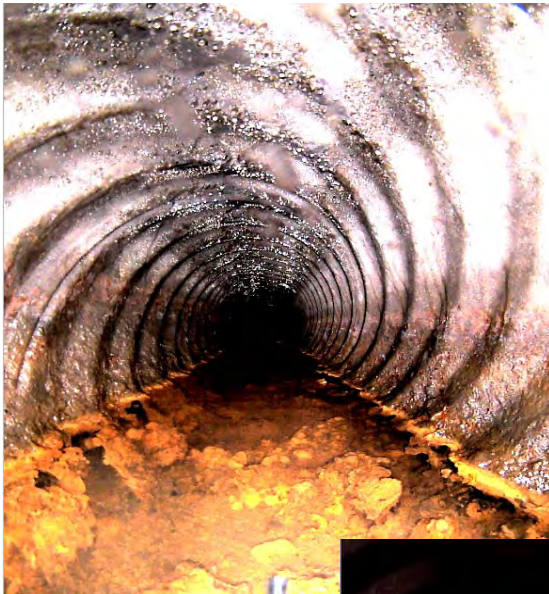
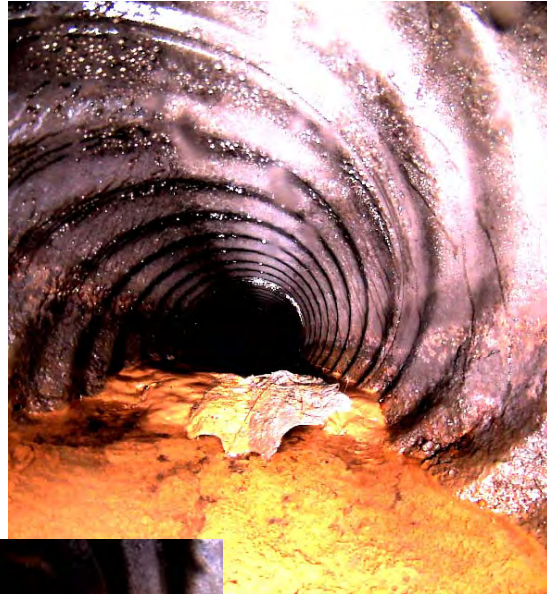
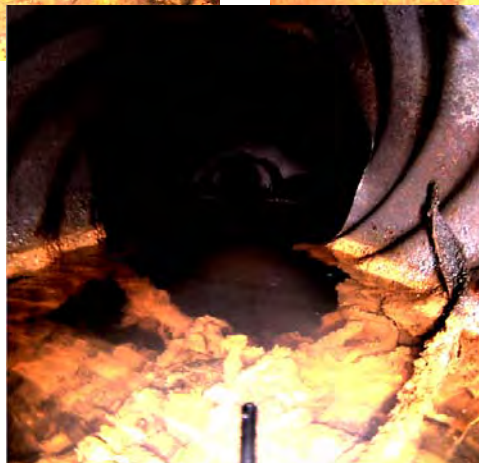
48th Avenue & Cordova Street Reconstruction CCTV #24471 - 48th Avenue and Old Seward Highway intersection

Other Notes: Large debris in pipe dams flow in a few locations. Invert rusted through and missing for all of visible length, especially obvious at upstream manhole (appears part of manhole wall missing as well).

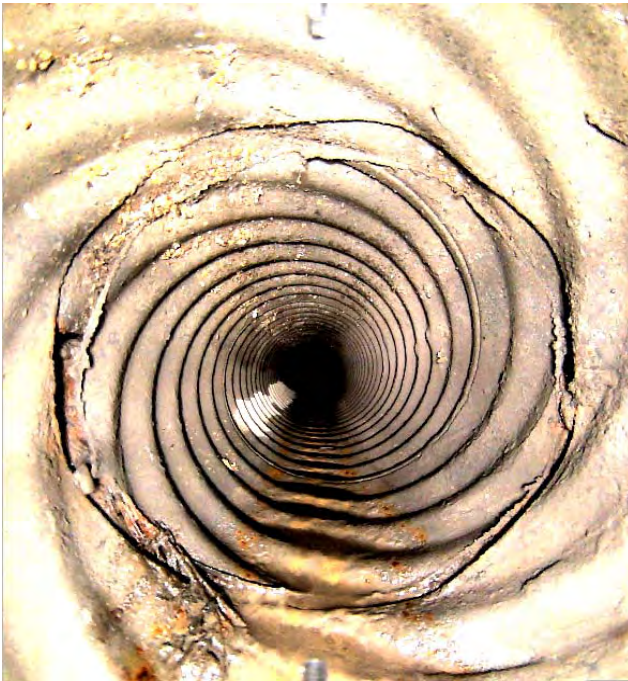
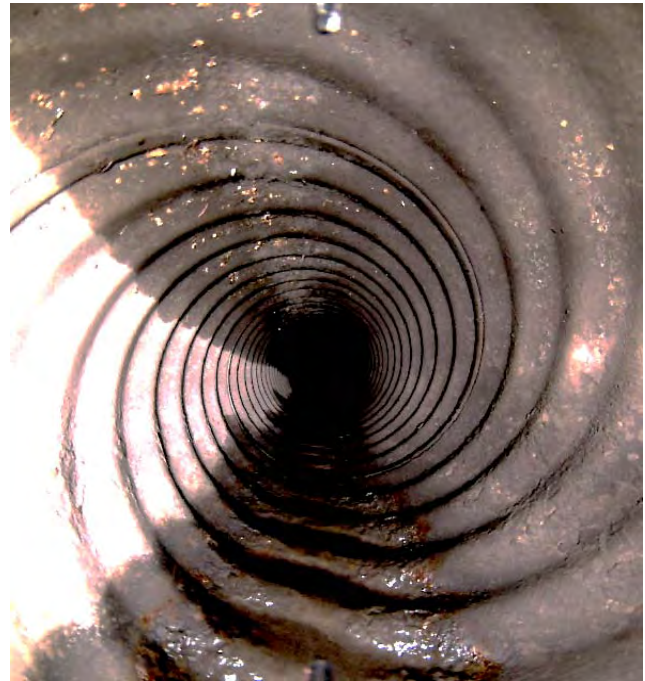
48th Avenue & Cordova Street Reconstruction CCTV #25510 - 48th Avenue and Gambell Street intersection

Other Notes: Pipe has small patches of rusting and small amount of debris buildup along invert. Minor joint offset present.

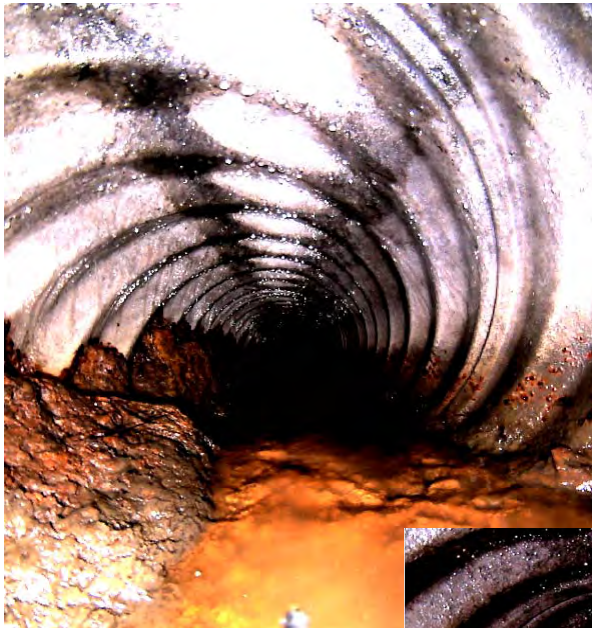
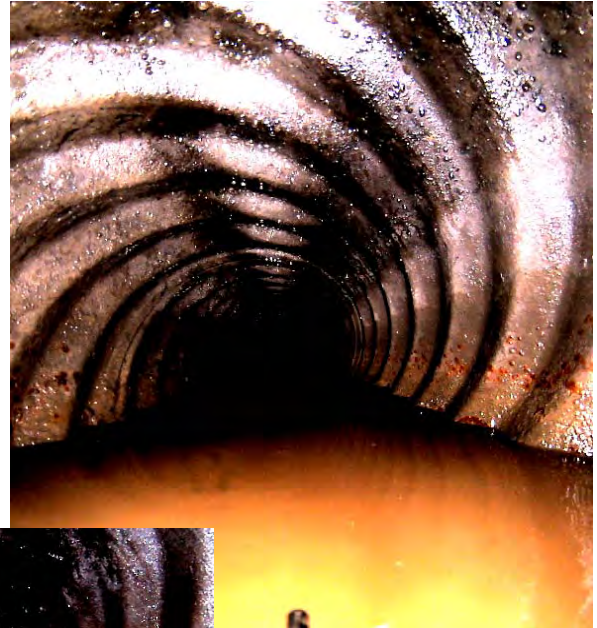
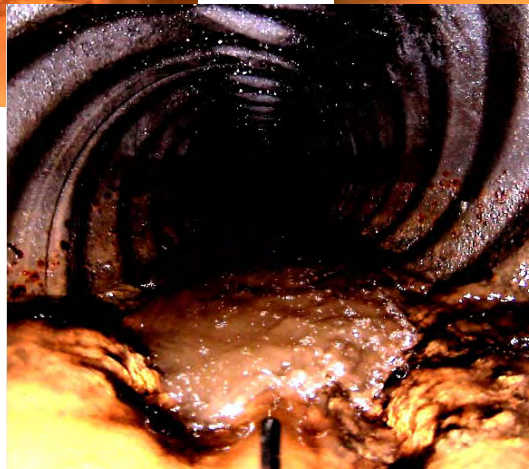
48th Avenue & Cordova Street Reconstruction CCTV #25794 - 48th Avenue, near Old Seward Highway intersection

Other Notes: Pipe had deep flow that prevented the CCTV camera from proceeding for full length (missing around 20 feet of pipe length). Invert not visible due to depth of water. Large debris buildups in pipe dams flow in a few locations, though not fully visible in CCTV footage. Small patches of rusting visible on walls.

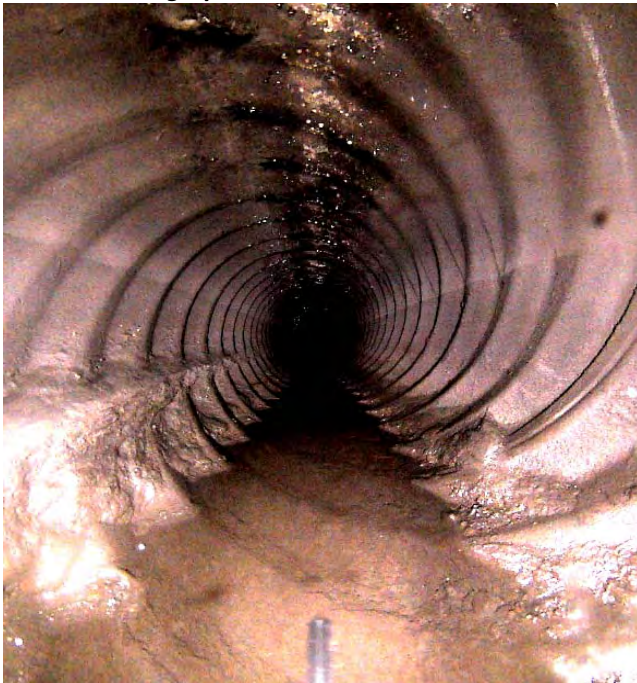
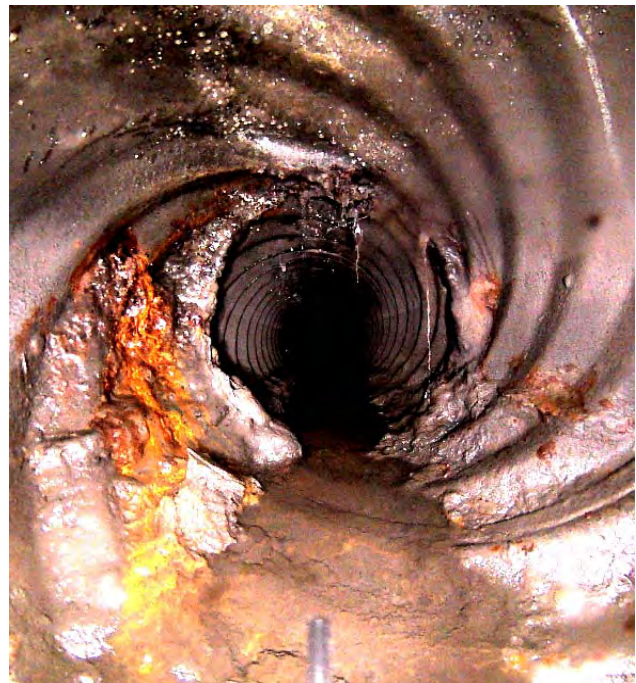
48th Avenue & Cordova Street Reconstruction CCTV #27090 - Gambell Street, near 48th Avenue intersection

Debris Present? Moderate debris/infiltration buildup

Other Notes: Pipe is mostly in good condition, except for one significant infiltration spot, and debris buildup along walls for most of the length.

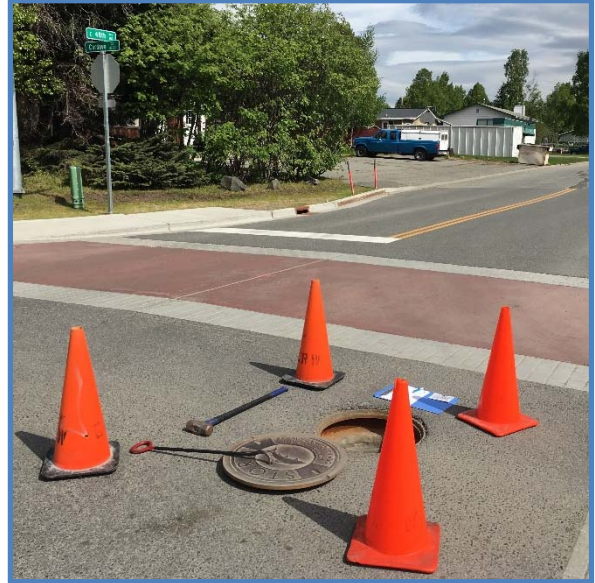
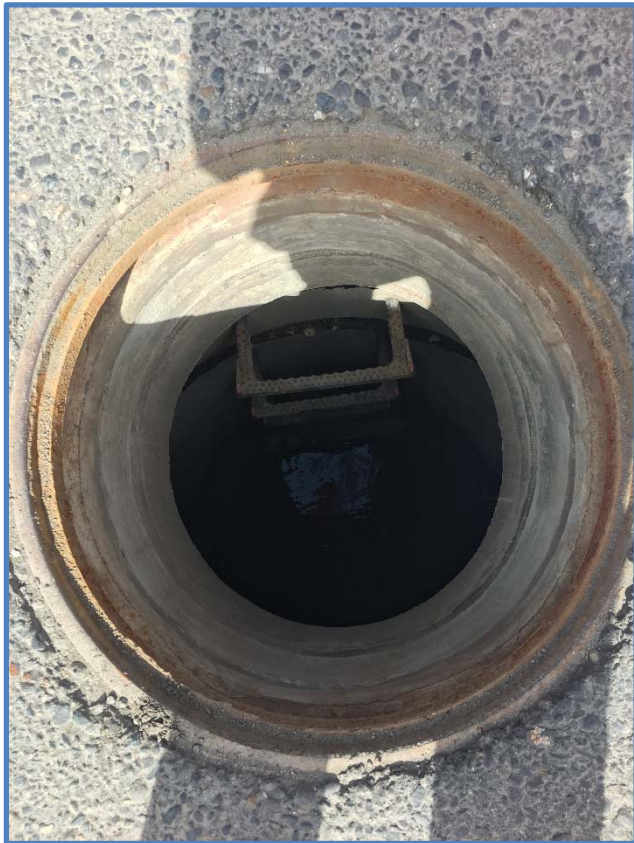
Manhole No. SW1831-233

- Recently constructed
- Overall structure in good condition

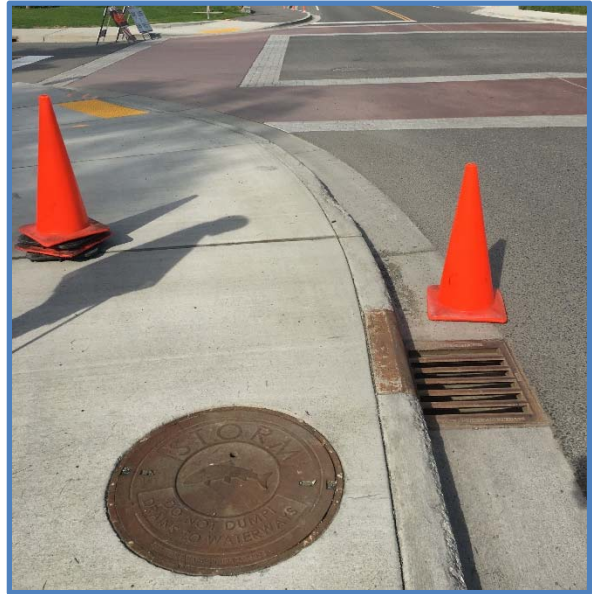
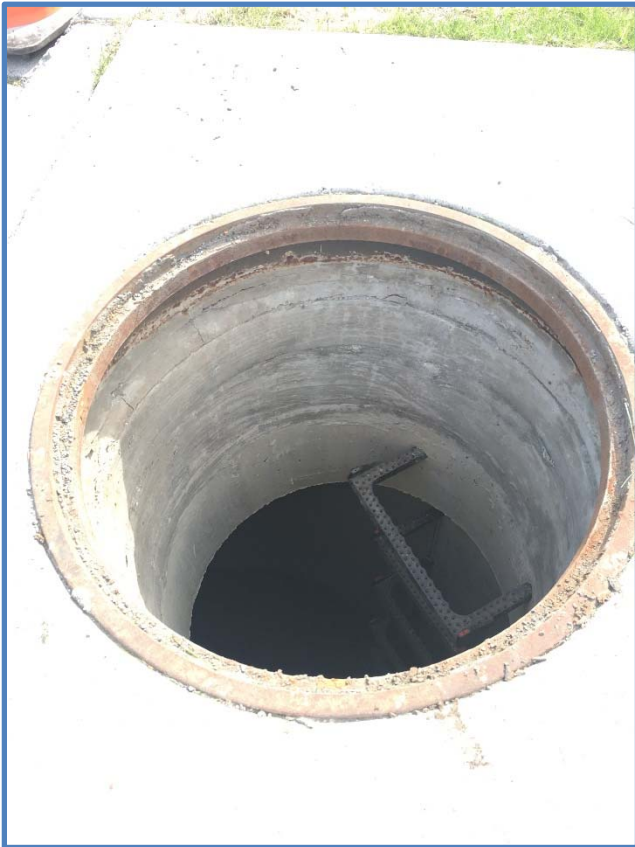
Manhole No. SW1831-236

- Recently constructed
- MH opening and curb inlet are not aligned perpendicular to roadway
- Overall structure in good condition

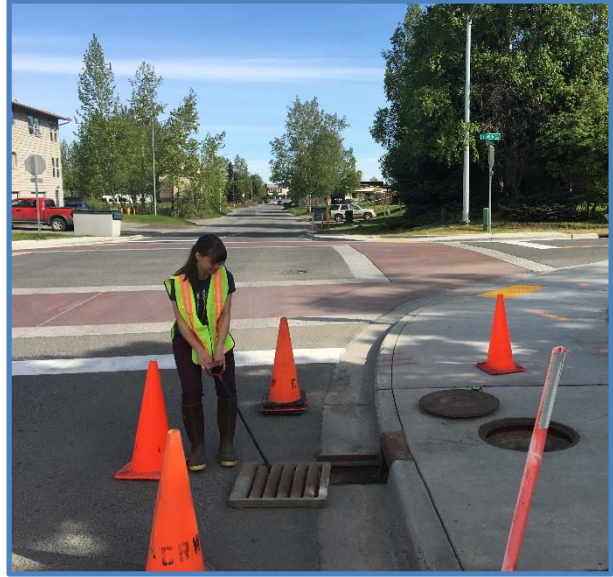
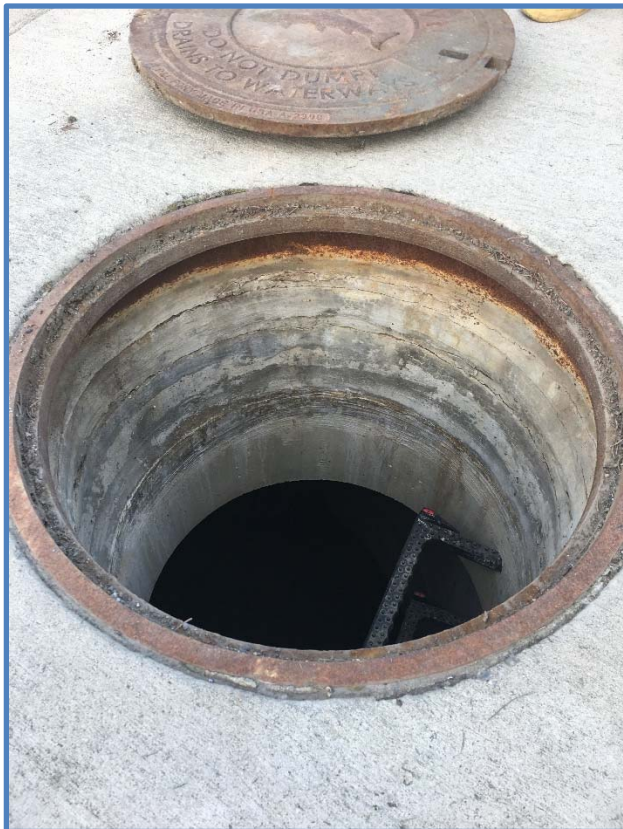
Manhole No. SW1831-237

- Recently constructed
- 8-10" CPEP pipe coming from east is not shown on WMS mapping
- Overall structure in good condition

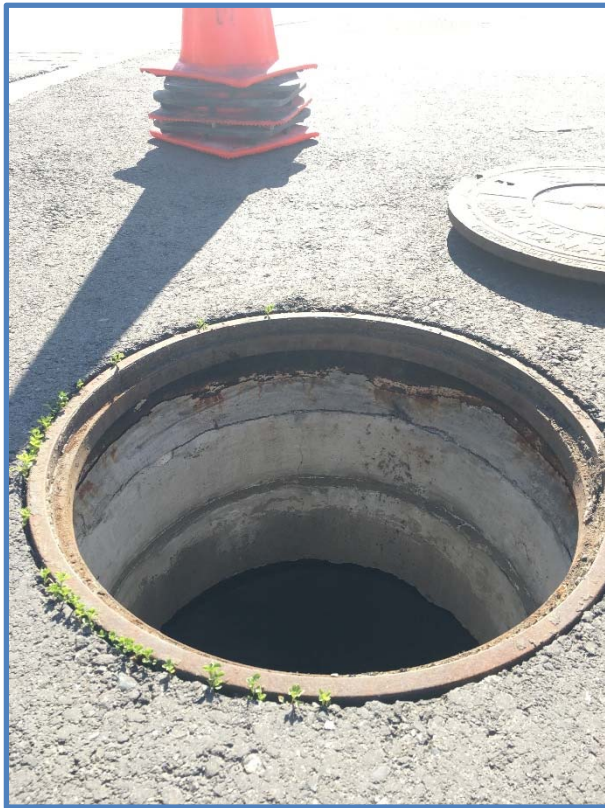
Photo 3 - Frame, Grade Rings & Reducing Slab

- Recently constructed
- South invert shows some grout spalling
- No cone, 8" reducing slab
- Overall structure in good condition

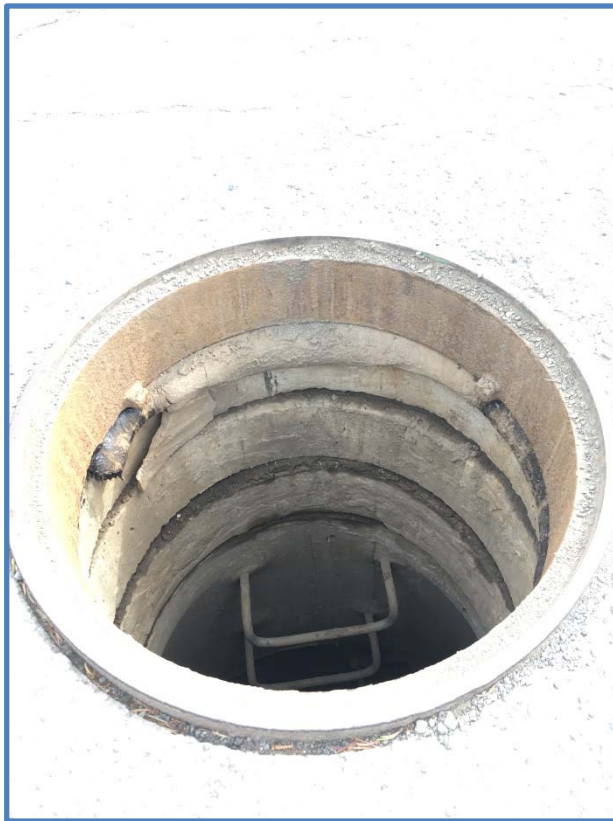
Manhole No. SW1831-073

- Non-standard lid
- Minor offset between grade rings and frame
- Eccentric cone
- Non-standard steel ladder rungs (5)
- Grouting at manhole wall near pipe spalling
- Overall good/fair condition

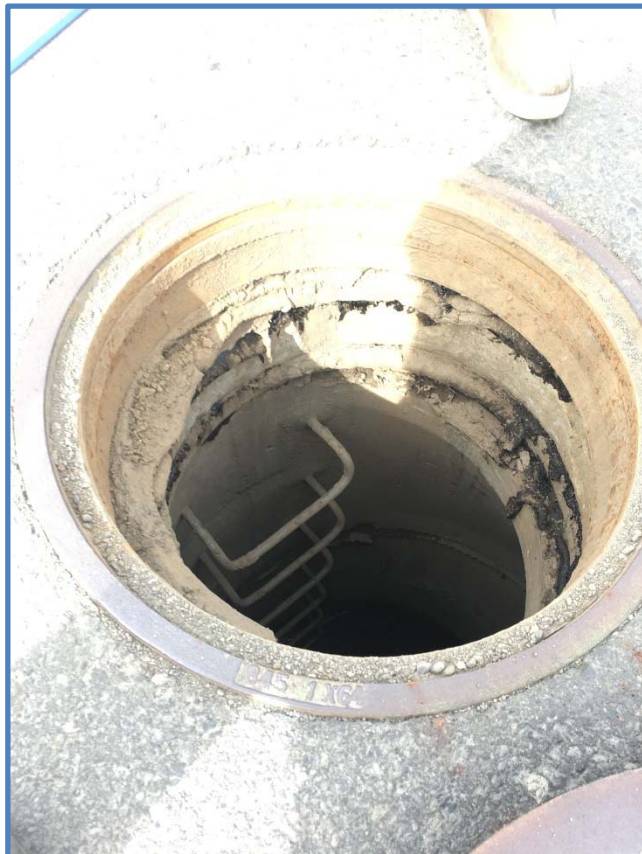
Manhole No. SW1831-074

- Non-standard lid
- Minor offset between cone and barrel, cone and grade rings, and grade rings and frame
- Eccentric cone
- Non-standard steel ladder rungs (6)
- South pipe has a CPEP cap over the end that is dripping, unsure of purpose
