Storm Drain Condition Assessment Reports

Memorandum

Date: July 2, 2019
From: Marliese von Huene, P.E. & Joey Hegna, P.E. – CRW Engineering Group, LLC
Project: 48th Avenue and Cordova Street Reconstruction
Project No: PM&E# 06-26 (CRW# 10143.00)
Subject: CCTV Storm Drain Condition Assessment

Date: July 2, 2019
From: Marliese von Huene, P.E. & Joey Hegna, P.E. – CRW Engineering Group, LLC
Project: 48th Avenue and Cordova Street Reconstruction
Project No: PM&E# 06-26 (CRW# 10143.00)
Subject: Storm Drain Manhole Condition Assessment

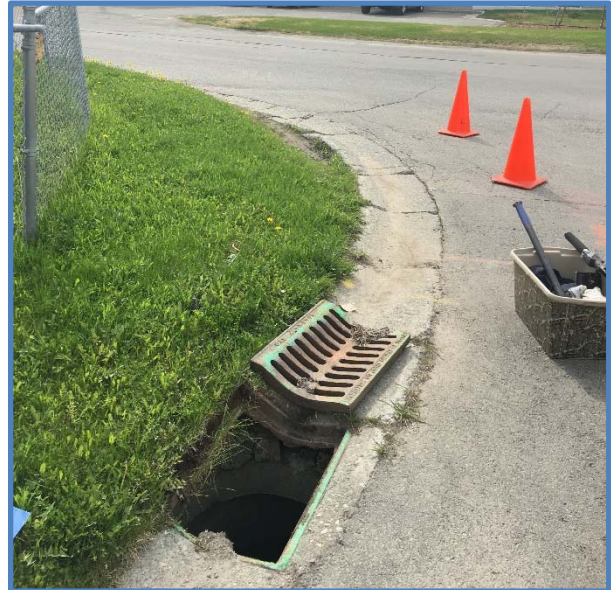
Manhole No. SW1831-090

- Type 2 curb inlet grate and frame
- Vegetation growing into frame
- No grade rings, supported by bricks (in poor condition) placed on reducing slab
- Overall structure in good/fair condition

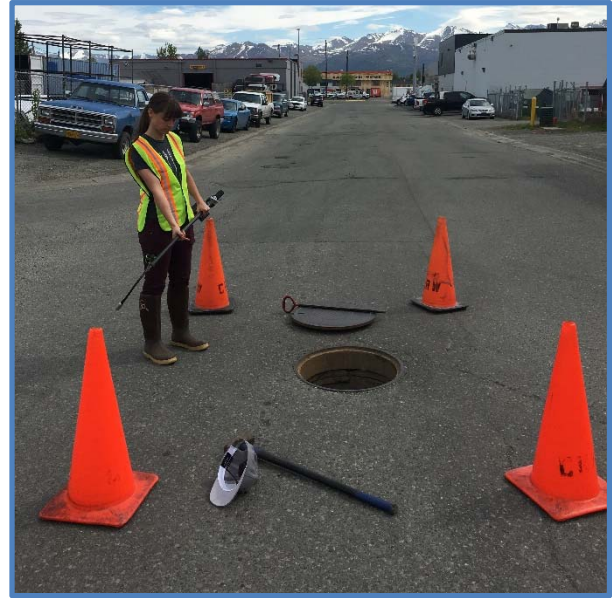
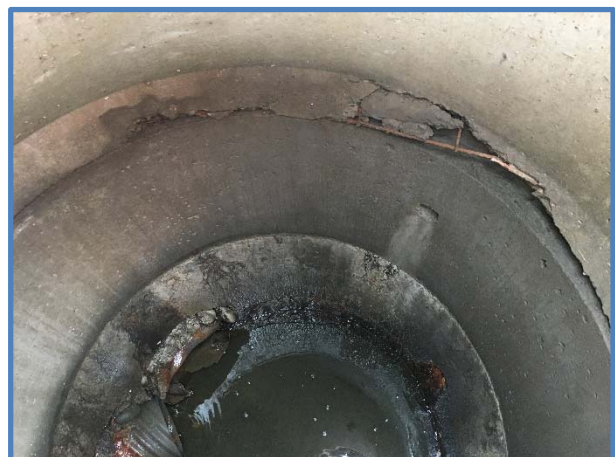
Manhole No. SW1831-024

- Non-standard lid
- Minor offset between lid and grade rings
- Eccentric cone
- Steel ladder rungs (7)
- Barrel ok (2 sections), Inflow at bottom barrel joint
- Minor vertical cracking in grade rings
- Pipe penetrations show sings of spalling/degradation
- Rebar exposed at bottom of cone section (south side)

Photo 2 - Cone Damage, Exposed Steel
