Storm Drain Condition Assessment Reports

Date: July 2, 2019
From: Marliese von Huene, P.E. & Joey Hegna, P.E. – CRW Engineering Group, LLC
Project: 48th Avenue and Cordova Street Reconstruction
Project No: PM&E# 06-26 (CRW# 10143.00)
Subject: CCTV Storm Drain Condition Assessment

48th Avenue & Cordova Street Reconstruction CCTV
Area 1 - 48th Avenue and Cordova Street intersection

Date: July 2, 2019
From: Marliese von Huene, P.E. & Joey Hegna, P.E. – CRW Engineering Group, LLC
Project: 48th Avenue and Cordova Street Reconstruction
Project No: PM&E# 06-26 (CRW# 10143.00)
Subject: Storm Drain Manhole Condition Assessment

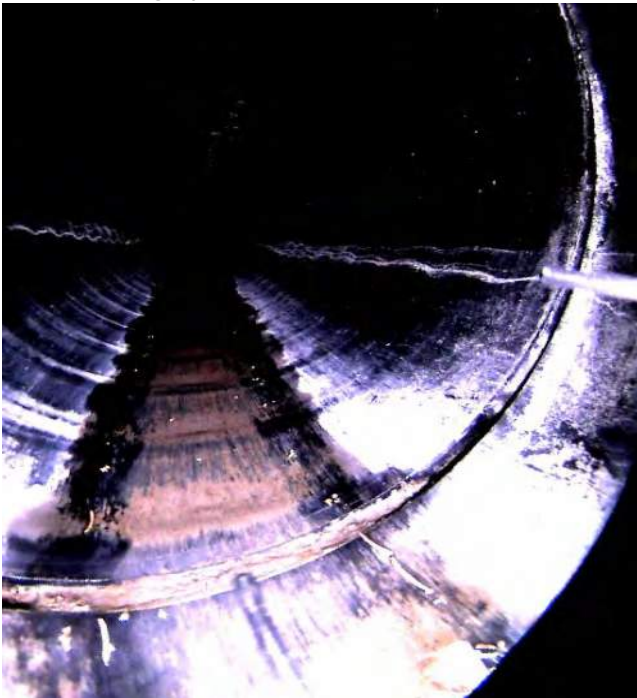
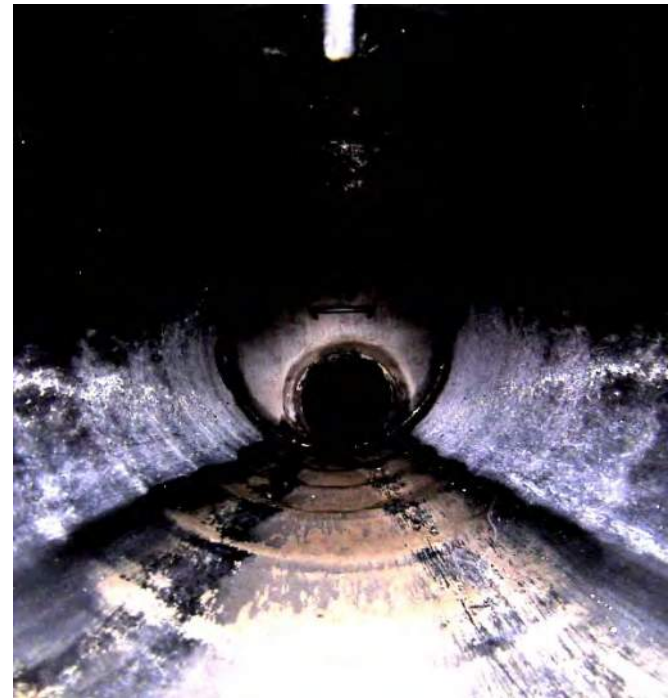
48th Avenue & Cordova Street Reconstruction CCTV #12033 - Cordova Street, near 48th Avenue intersection

Other Notes: Pipe appears to be in good condition, minor joint offset

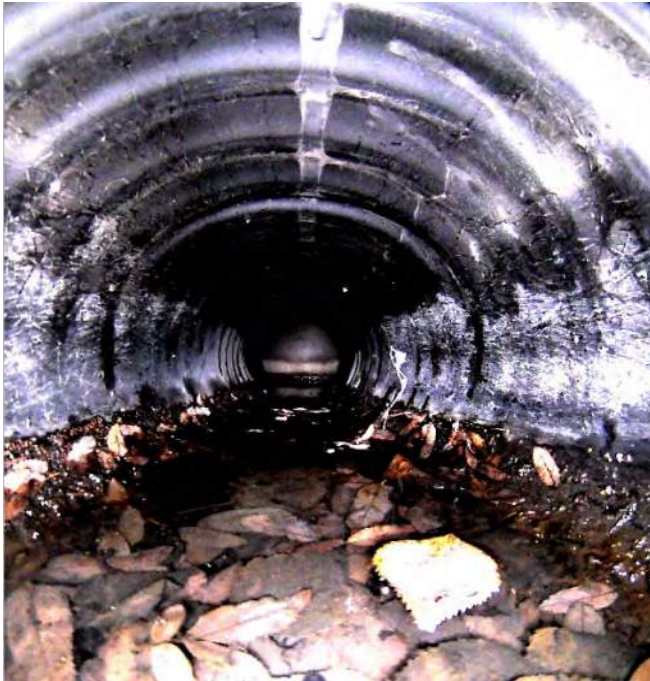
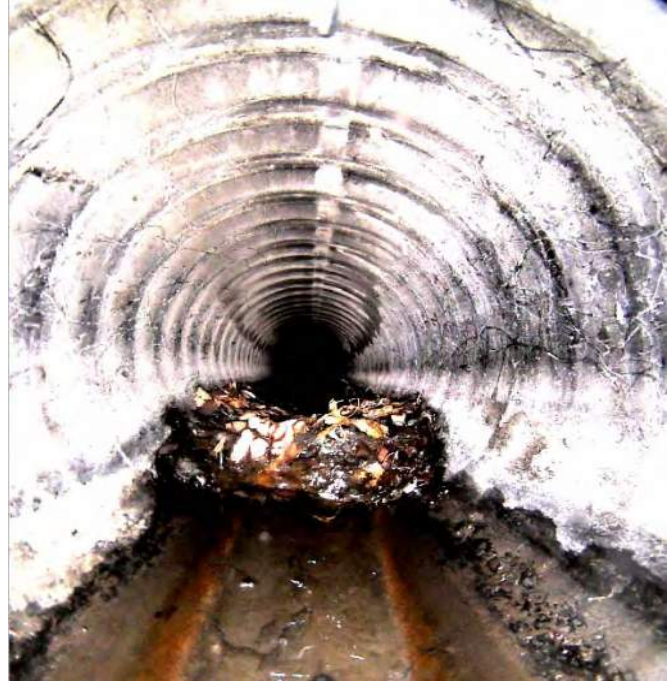
48th Avenue & Cordova Street Reconstruction CCTV #14303 - 48th Avenue, near Cordova Street intersection

Debris Present? Significant leaf buildup

Other Notes: Pipe appears to be in good condition, but leaf buildup is restricting flow. Looks like some root intrusion is possible along walls.

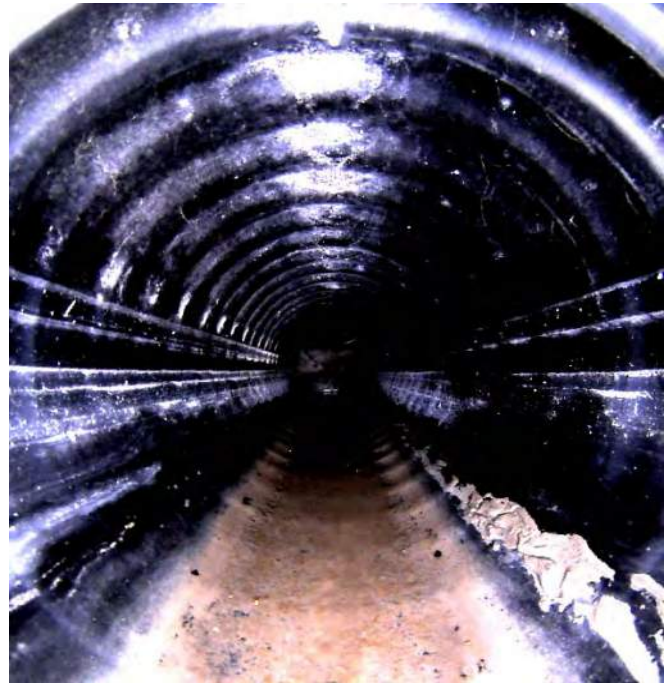
48th Avenue & Cordova Street Reconstruction CCTV #22397 - 48th Avenue, near Cordova Street intersection

Other Notes: Pipe appears to be in good condition, minor joint offset

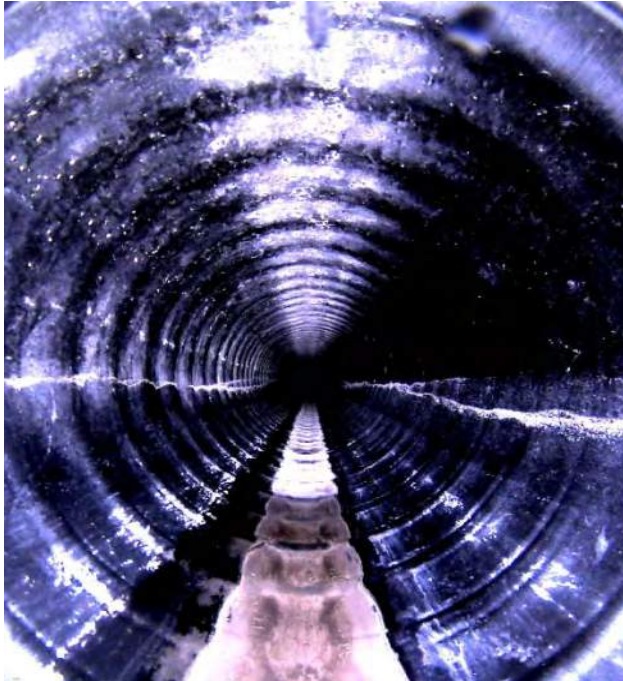
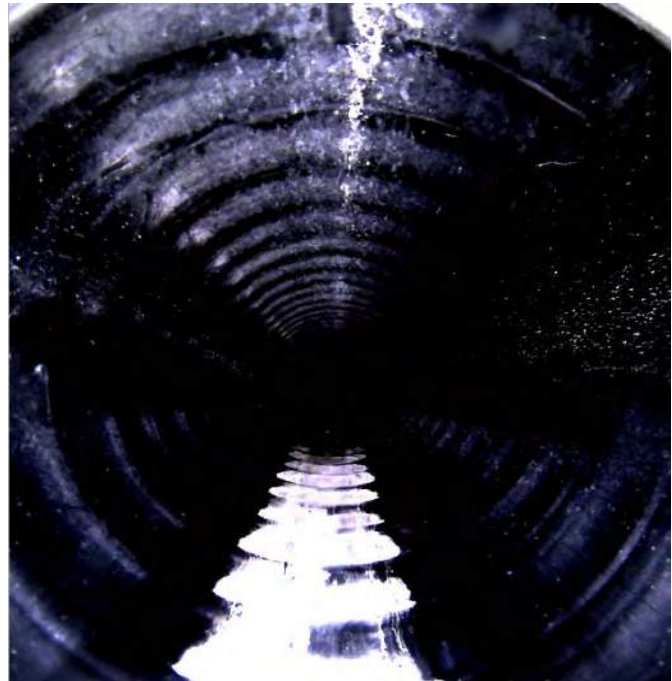
48th Avenue & Cordova Street Reconstruction CCTV
#39158 - Cordova Street, near 48th Avenue intersection

Other Notes: Pipe appears to be in good condition

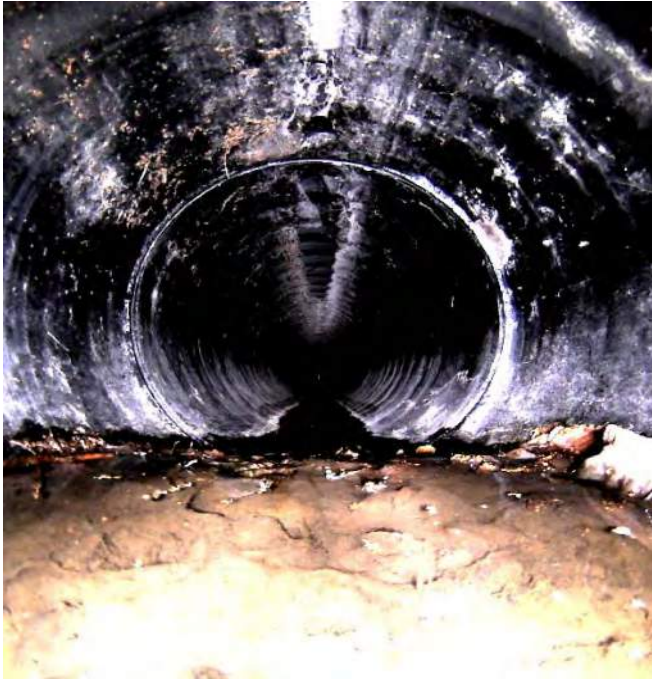
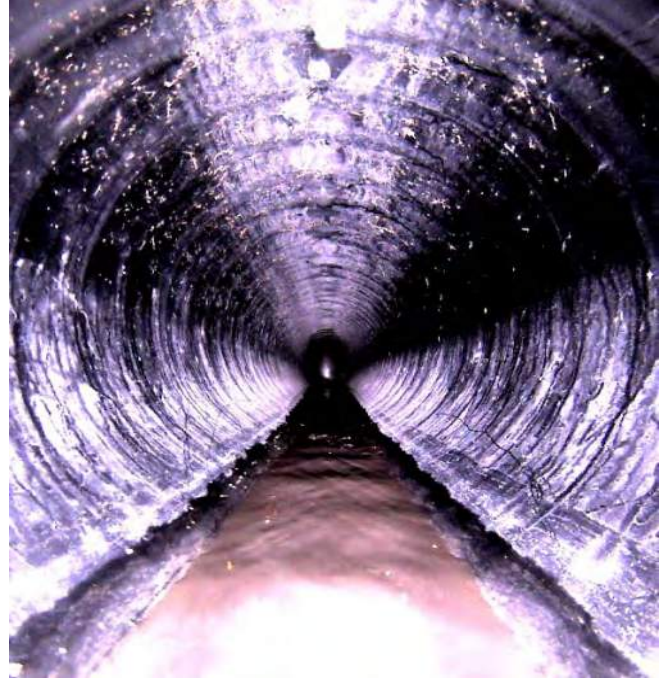
48th Avenue & Cordova Street Reconstruction CCTV #39159 - 48th Avenue, near Cordova Street intersection

Debris Present? Significant leaf buildup

Other Notes: Pipe appears to be in good condition, but leaf buildup is restricting flow.

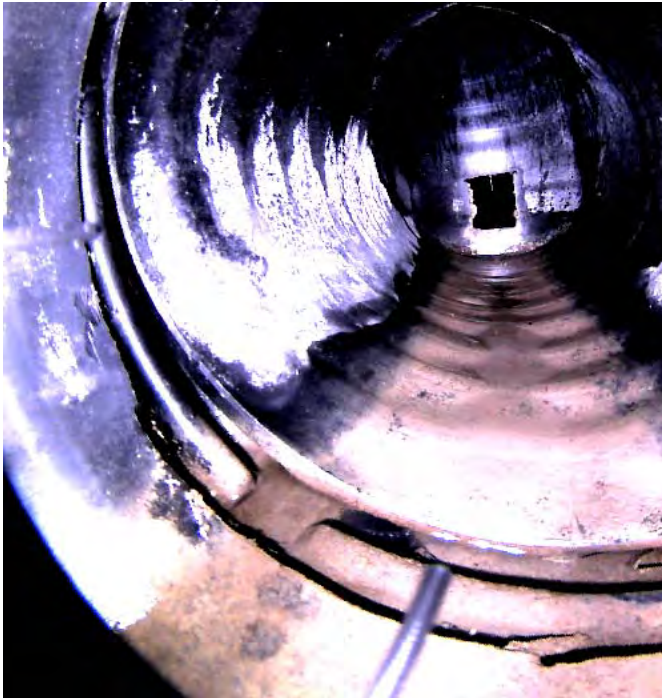
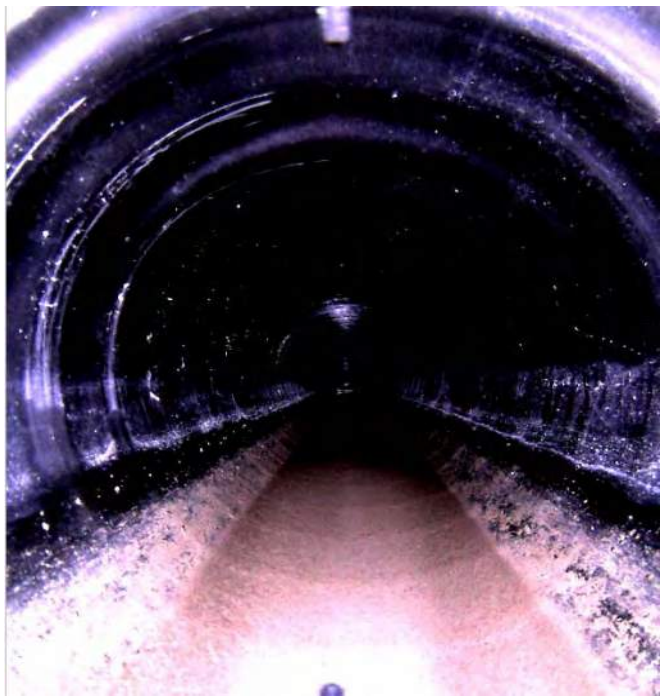
48th Avenue & Cordova Street Reconstruction CCTV #39160 - 48th Avenue, near Cordova Street intersection

Other Notes: Pipe appears to be in good condition, one joint offset

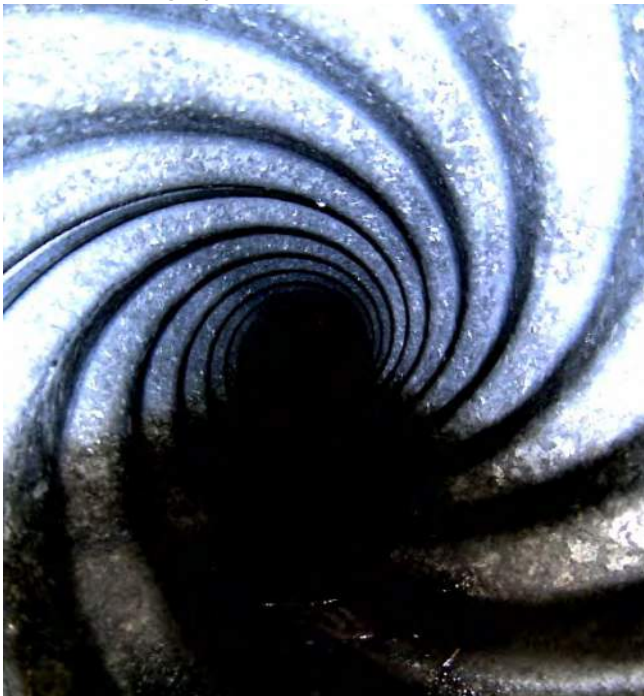
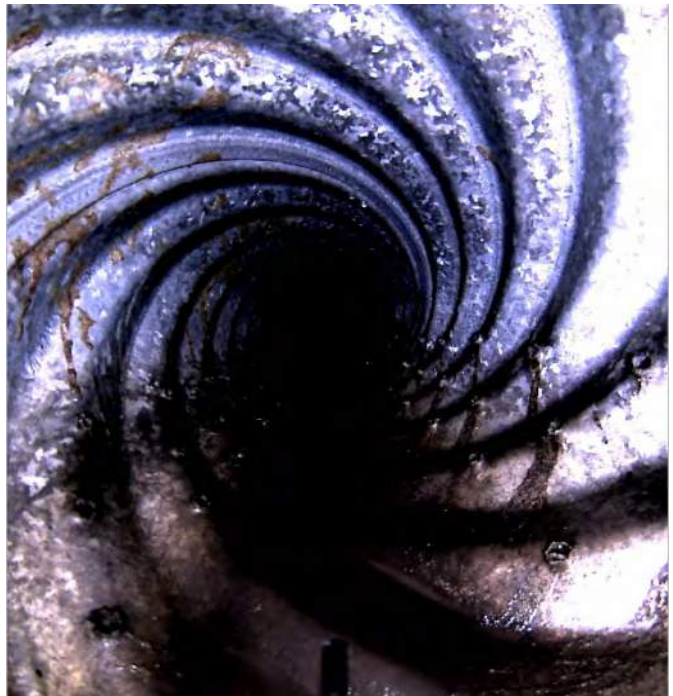
48th Avenue & Cordova Street Reconstruction CCTV #25910 - 48th Avenue, near Eagle Street intersection

Other Notes: Pipe appears to be in good condition, but lighting made it difficult to see the bottom half of the pipe.

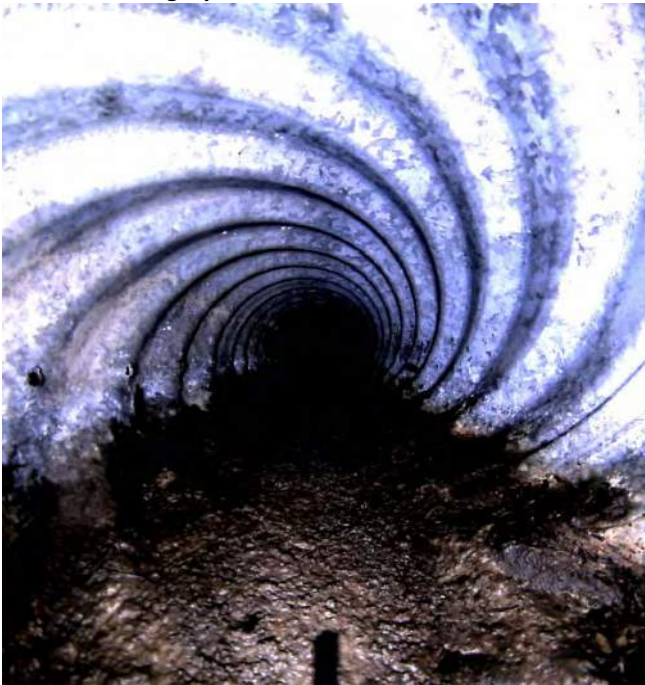
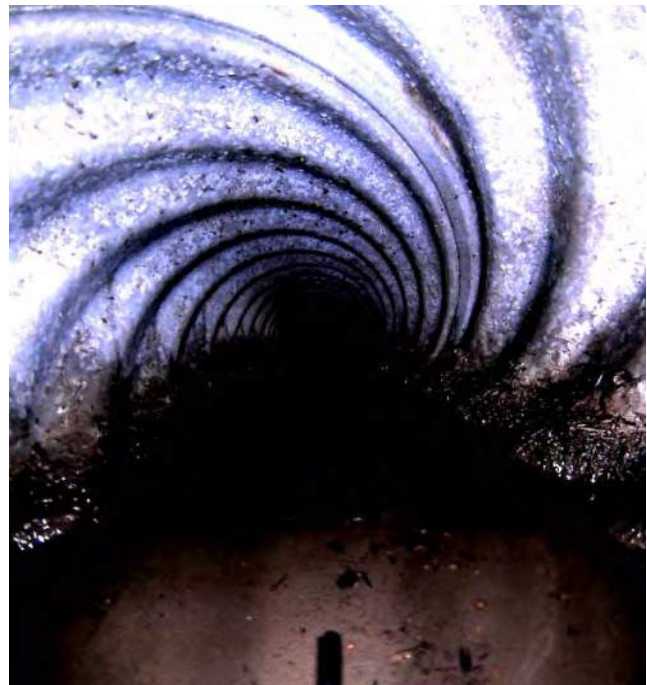
48th Avenue & Cordova Street Reconstruction CCTV #29685 - 48th Avenue, near Eagle Street intersection

Other Notes: Visible pipe appears to be in good condition, but significant buildup is restricting and backing up flow.

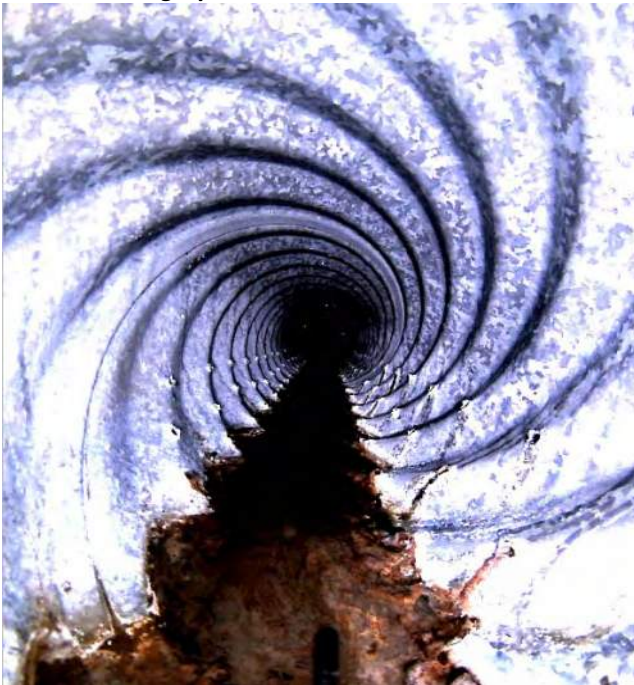
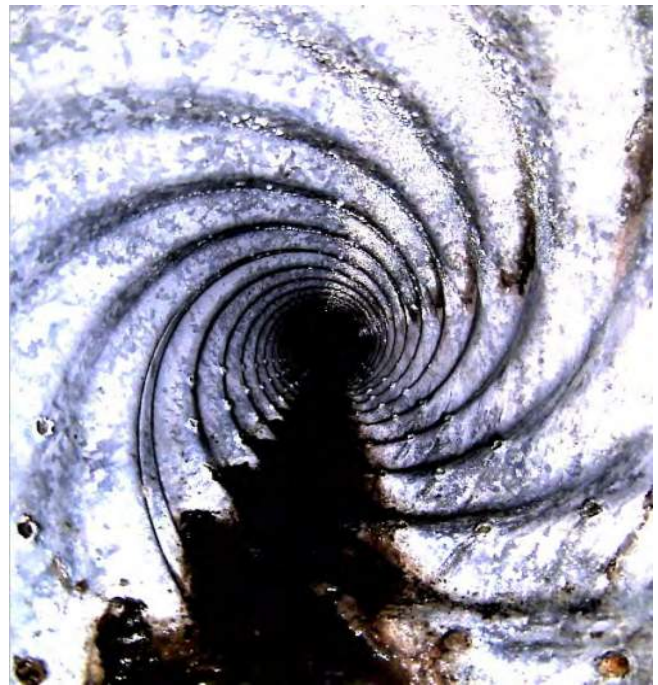
48th Avenue & Cordova Street Reconstruction CCTV #32710 - Denali Street, near 48th Avenue intersection

Other Notes: Pipe appears to be in good condition

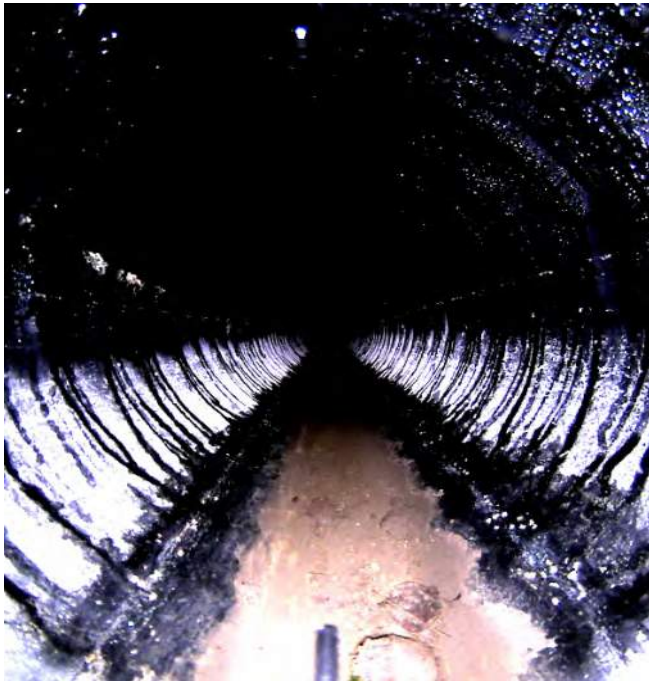
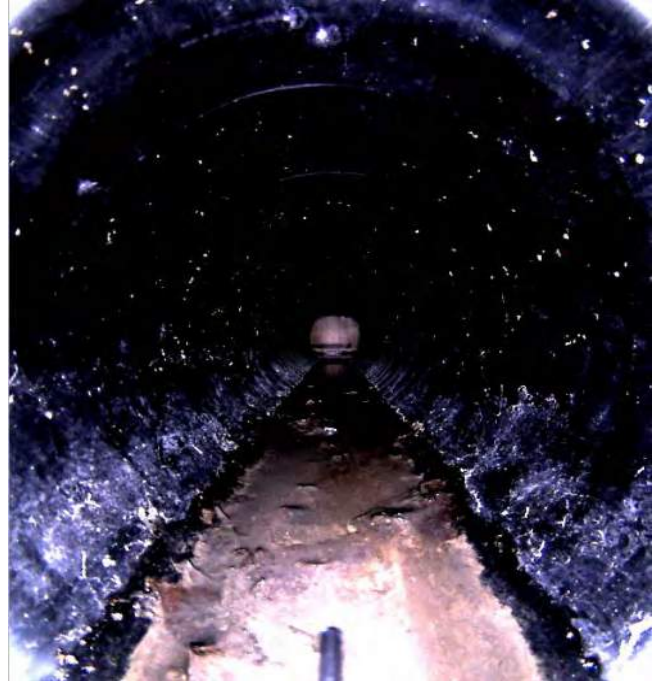
48th Avenue & Cordova Street Reconstruction CCTV #34751 - Eagle Street, near 48th Avenue intersection

Other Notes: Pipe appears to be in good condition

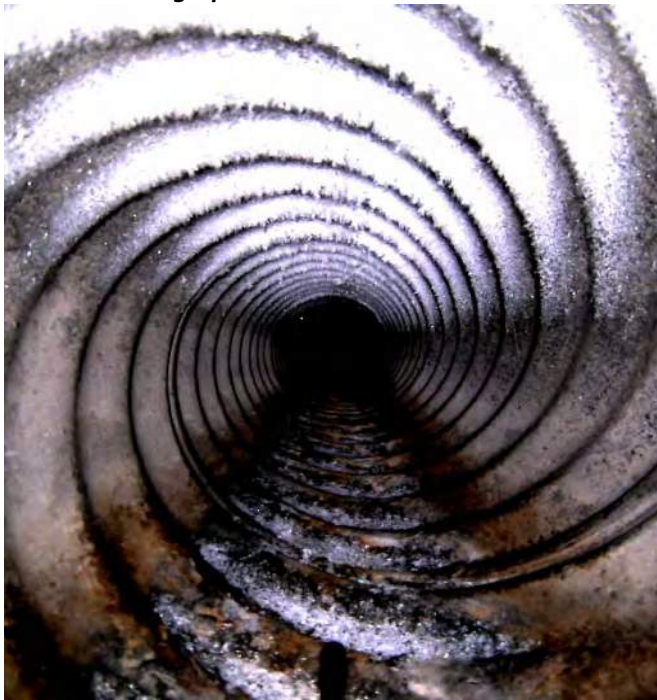
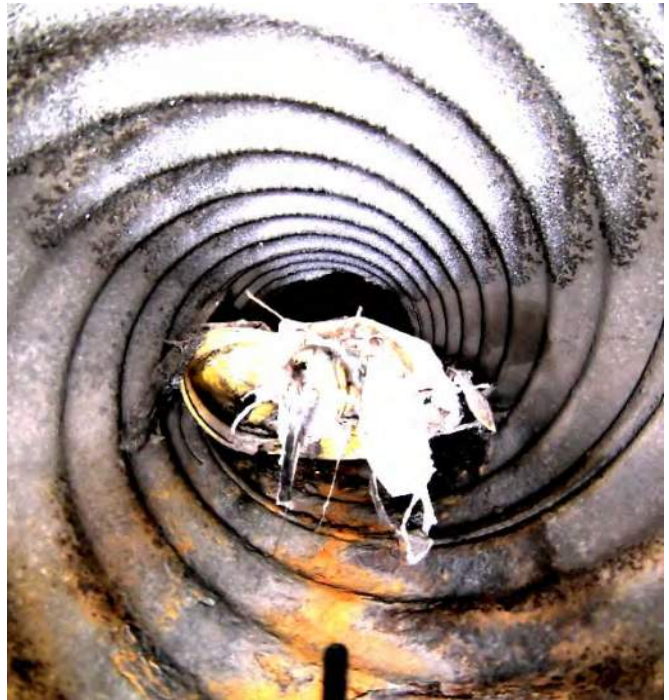
48th Avenue & Cordova Street Reconstruction CCTV #12998 - Old Seward Highway, near 48th Avenue intersection

Other Notes: Large debris in pipe will block high flows. Pipe appears to be close to surface - significant freezing seen on pipe top. Invert rusted in most of length.

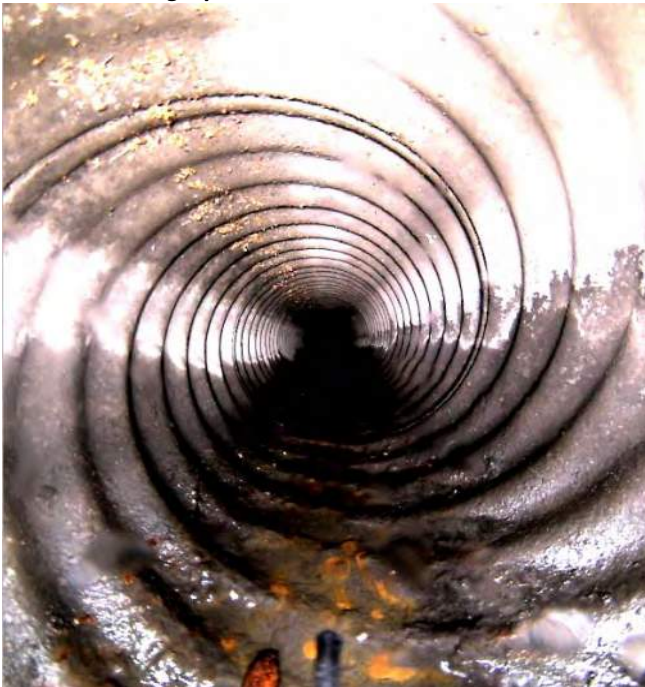
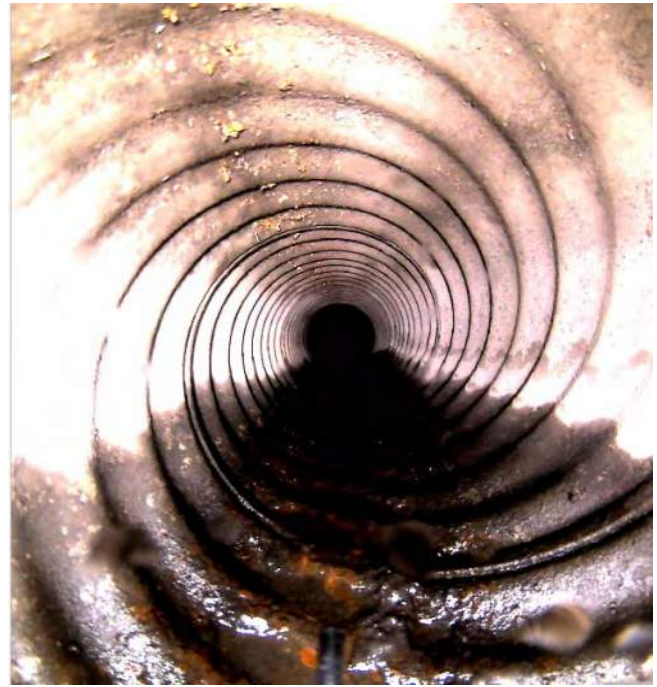
**48th Avenue & Cordova Street Reconstruction CCTV
#15553 - 48th Avenue, near Old Seward Highway intersection**

Other Notes: Pipe has small patches of rusting and small amount of debris buildup along invert.

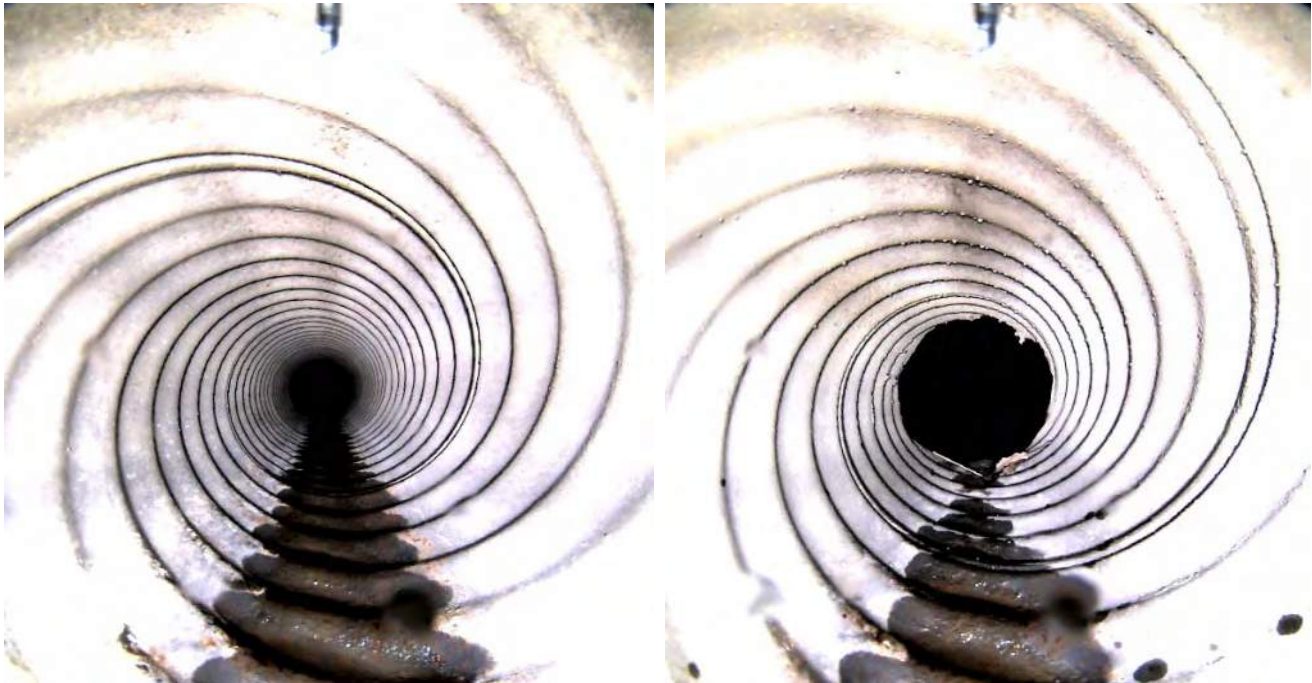
**48th Avenue & Cordova Street Reconstruction CCTV
#16178 - 48th Avenue, near Old Seward Highway intersection**

Other Notes: Pipe has small patches of rusting and small amount of debris buildup along invert.

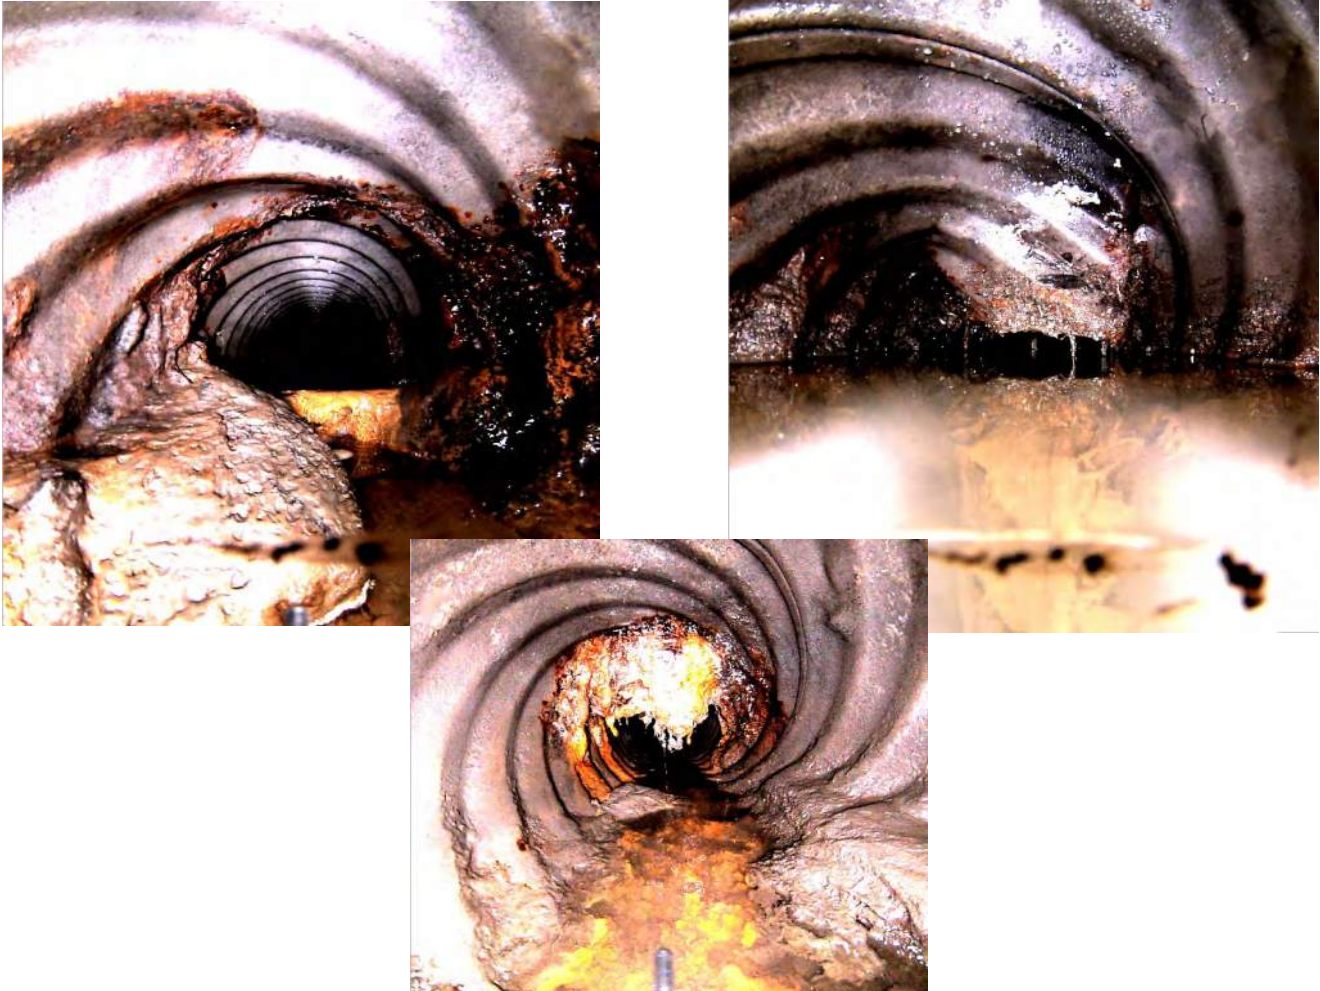
48th Avenue & Cordova Street Reconstruction CCTV #16710 - 48th Avenue, near Gambell Street intersection

Other Notes: Pipe has a large break that prevented the CCTV camera from proceeding for full length (second video started from other side, but still missing around 70 feet of middle pipe length). Large debris in pipe dams flow in a few locations. Invert rusted through and missing for most of visible length.

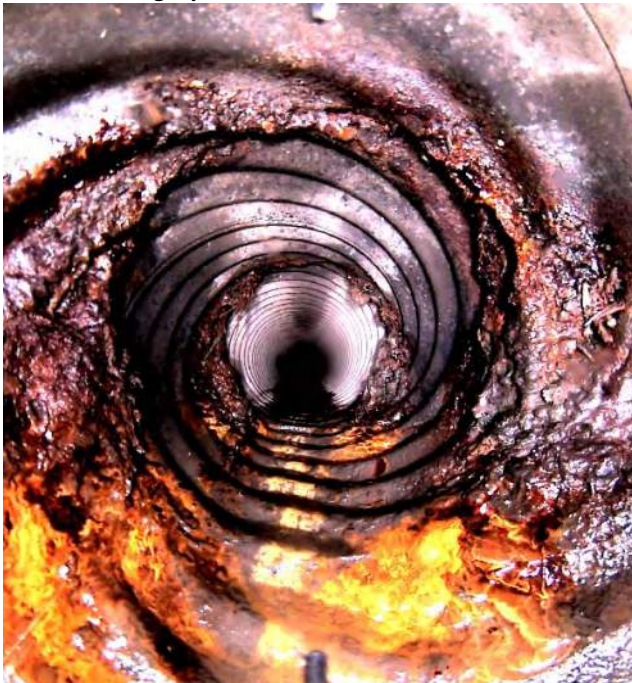
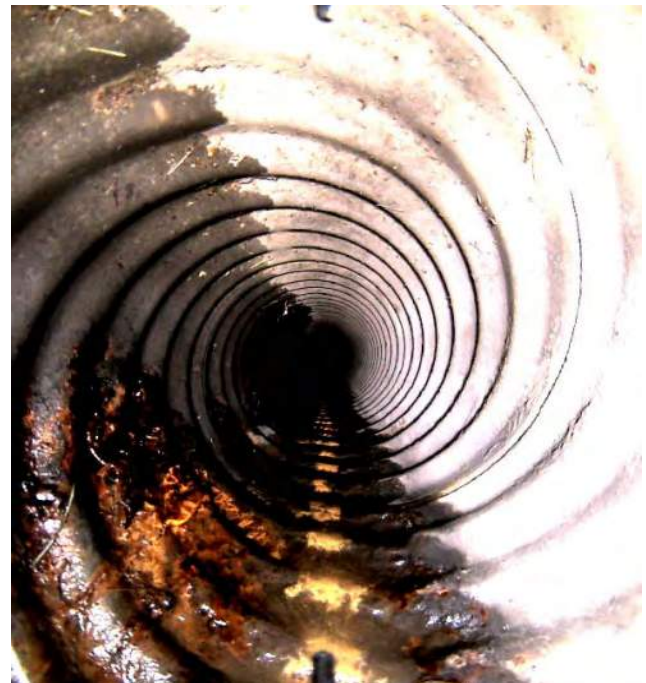
48th Avenue & Cordova Street Reconstruction CCTV #17134 - 48th Avenue and Gambell Street intersection

Debris Present? Minor/moderate infiltration buildup

Other Notes: Pipe is mostly in good condition, except for one significant infiltration section (about 2-3 feet long) and multiple smaller rust/infiltration spots nearby.

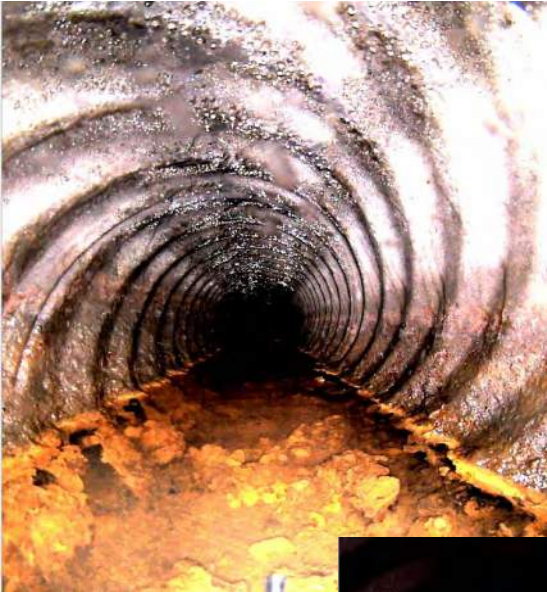
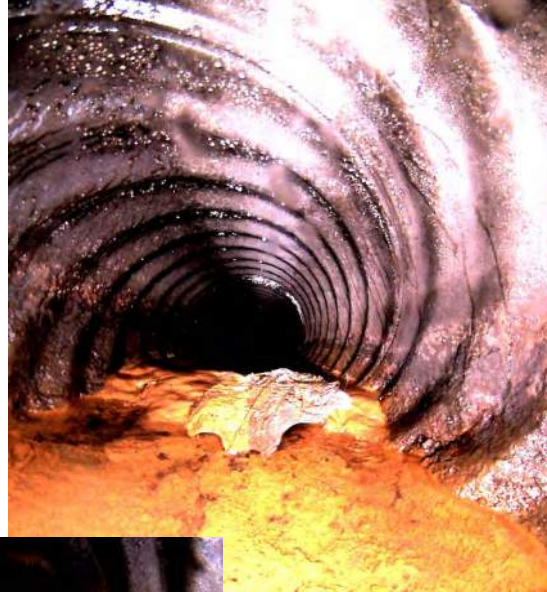
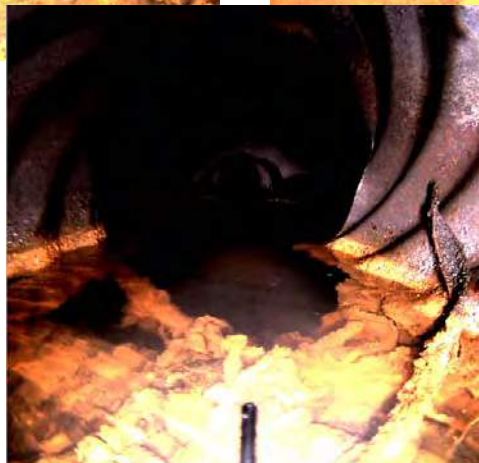
48th Avenue & Cordova Street Reconstruction CCTV #24471 - 48th Avenue and Old Seward Highway intersection

- The three primary 15-inch CMP segments along 48th Avenue (west of Old Seward Highway) are in poor condition, with large sediment/debris deposits obstructing flow in several locations. In addition, the inverts are missing for most of the visible sections in the video, and one pipe has a partial collapse that prevented the camera from going through.
- The four 10-inch CMP catch basin leads/laterals along the 48th Avenue (west of Old Seward Highway) are in moderate condition, showing large debris buildup and corrosion along the length of the pipes.

Other Notes: Large debris in pipe dams flow in a few locations. Invert rusted through and missing for all of visible length, especially obvious at upstream manhole (appears part of manhole wall missing as well).

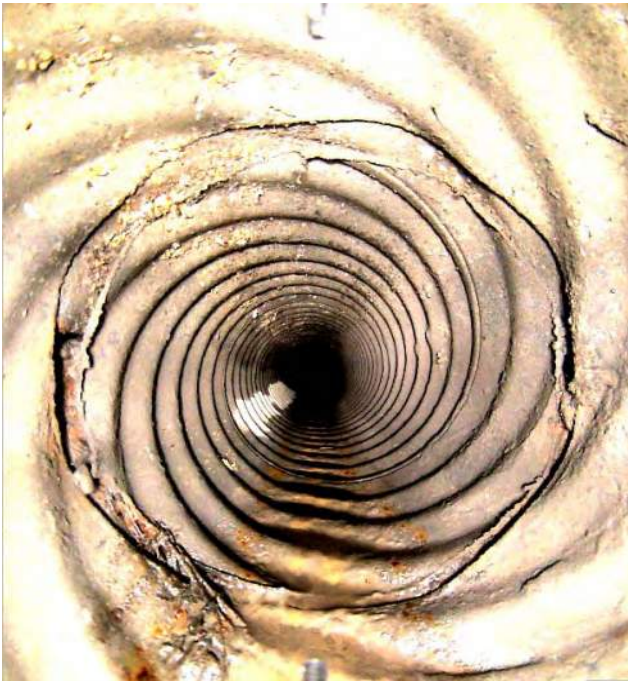
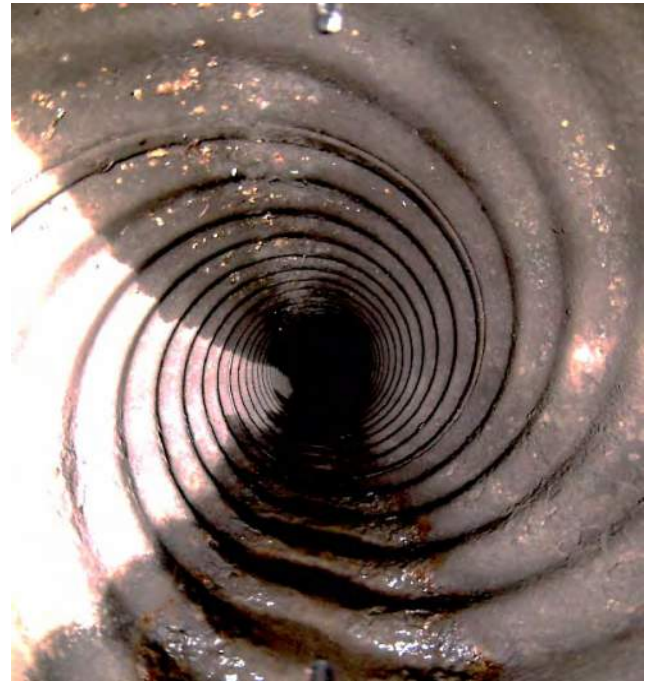
48th Avenue & Cordova Street Reconstruction CCTV #25510 - 48th Avenue and Gambell Street intersection

Other Notes: Pipe has small patches of rusting and small amount of debris buildup along invert. Minor joint offset present.

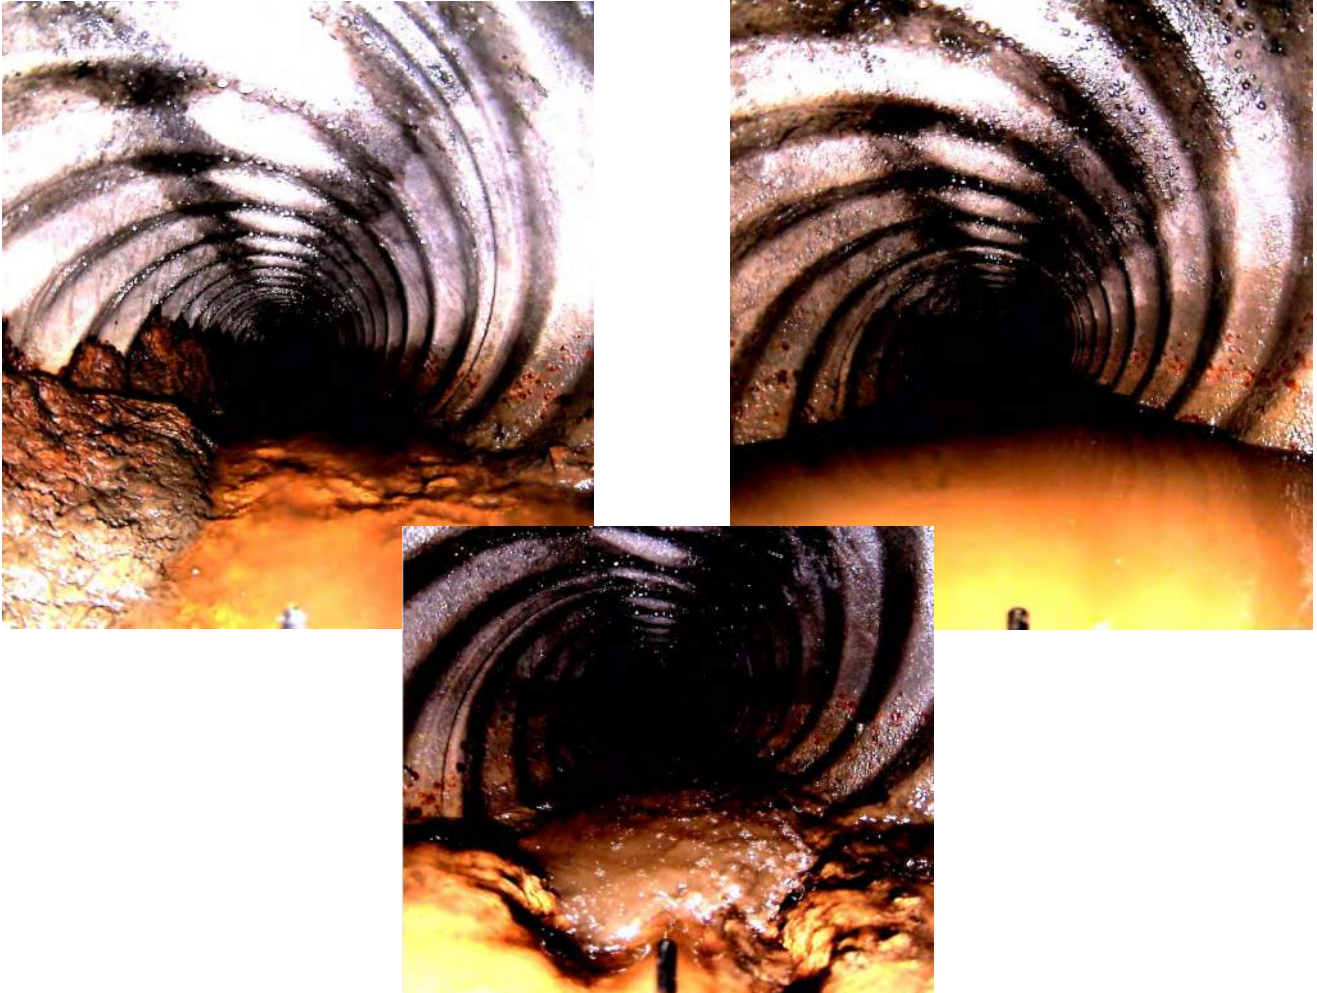
48th Avenue & Cordova Street Reconstruction CCTV #25794 - 48th Avenue, near Old Seward Highway intersection

Other Notes: Pipe had deep flow that prevented the CCTV camera from proceeding for full length (missing around 20 feet of pipe length). Invert not visible due to depth of water. Large debris buildups in pipe dams flow in a few locations, though not fully visible in CCTV footage. Small patches of rusting visible on walls.

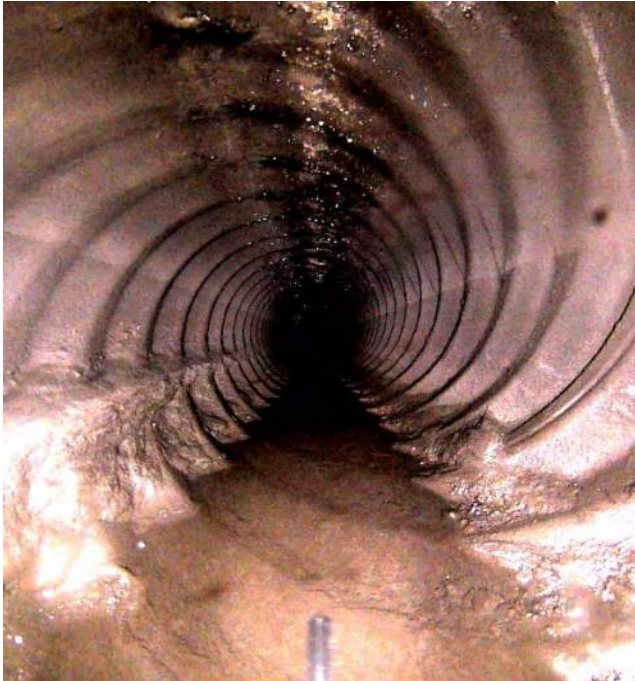
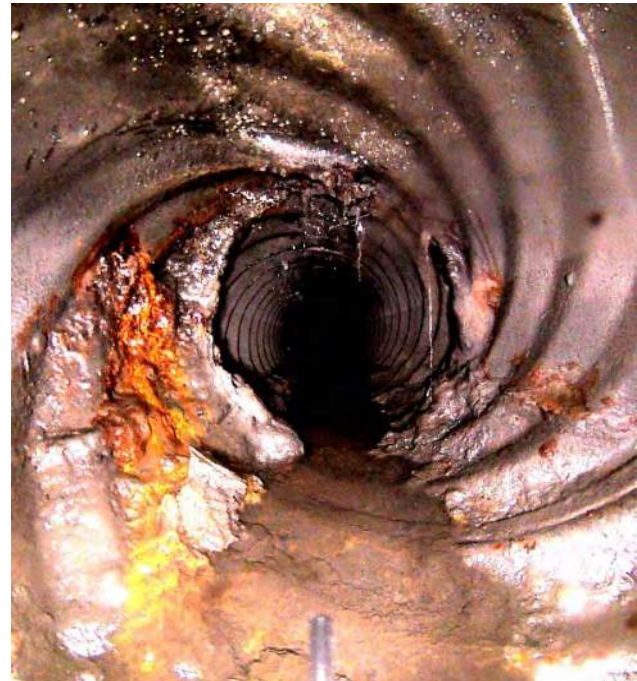
48th Avenue & Cordova Street Reconstruction CCTV #27090 - Gambell Street, near 48th Avenue intersection

Debris Present? Moderate debris/infiltration buildup

Other Notes: Pipe is mostly in good condition, except for one significant infiltration spot, and debris buildup along walls for most of the length.

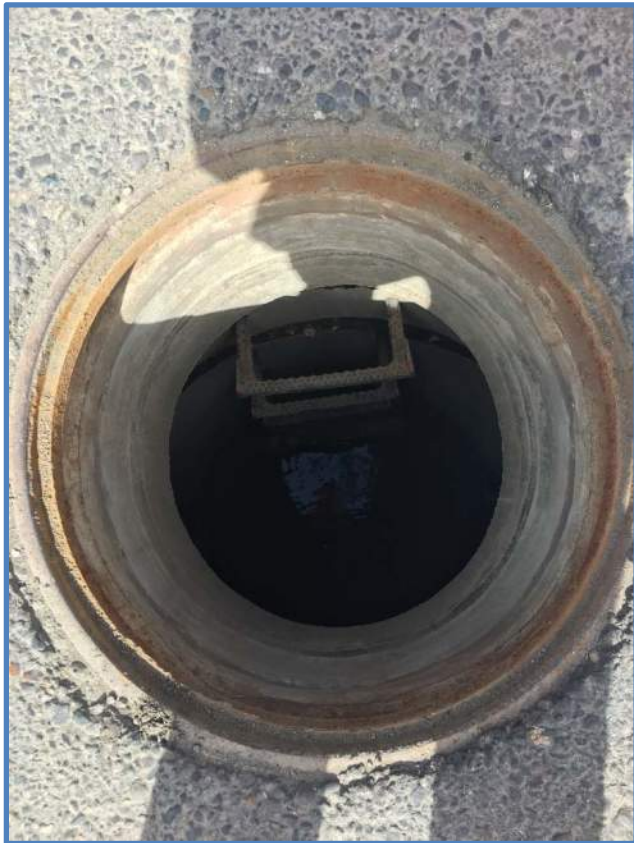
Photo 3 - Frame, Grade Rings & Ladder Rungs

- Recently constructed
- Overall structure in good condition

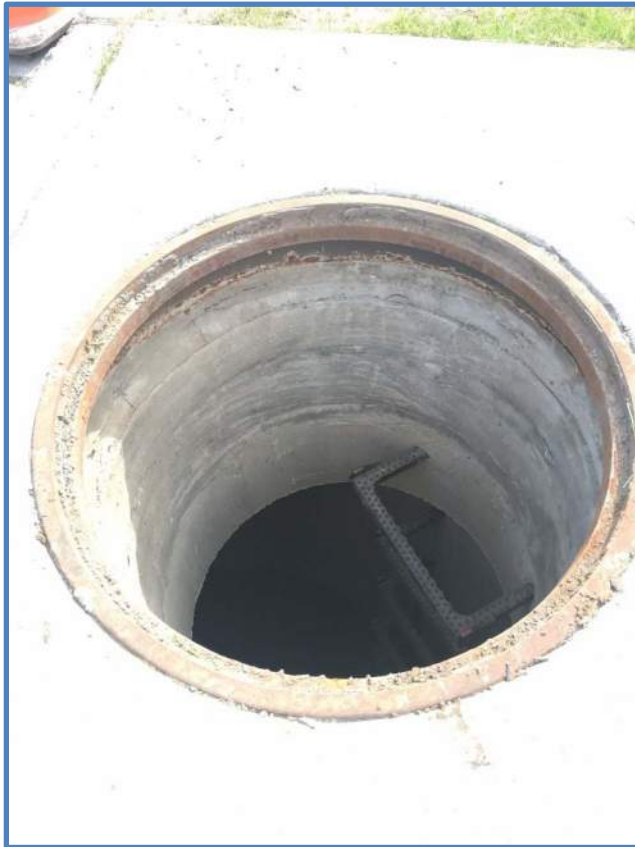
Photo 1 - Frame, Grade Rings & Ladder Rungs

- Recently constructed
- MH opening and curb inlet are not aligned perpendicular to roadway
- Overall structure in good condition

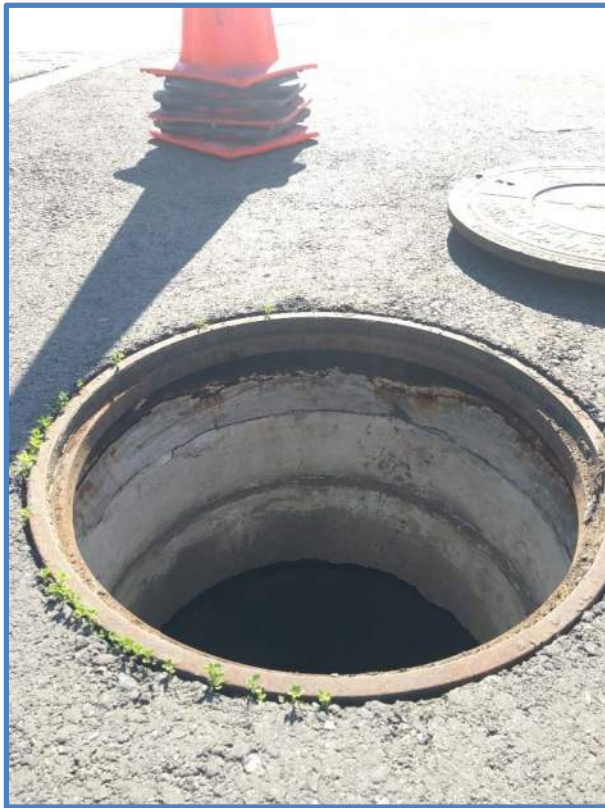
Photo 3 - Frame, Grade Rings & Reducing Slab

- Recently constructed
- South invert shows some grout spalling
- No cone, 8" reducing slab
- Overall structure in good condition

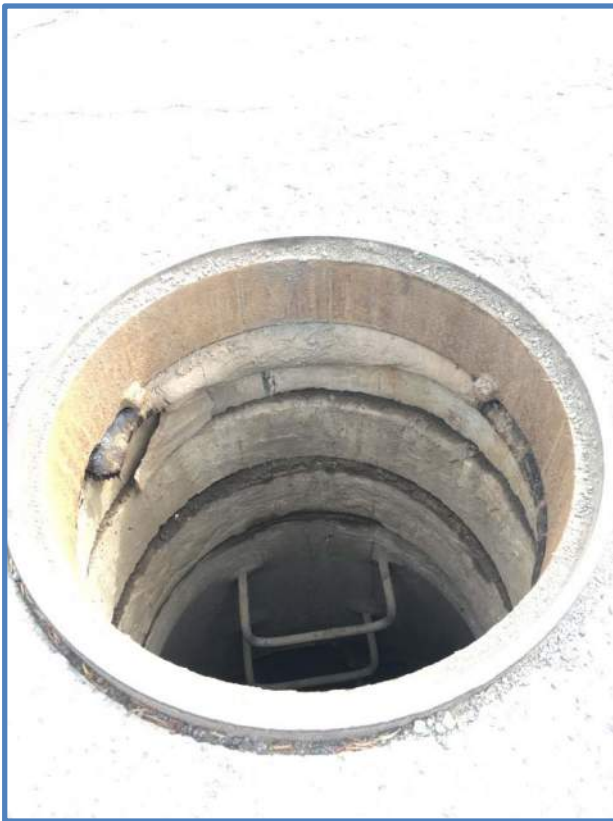
Photo 3 - Frame, Grade Rings & Ladder Rungs

- Non-standard lid
- Minor offset between grade rings and frame
- Eccentric cone
- Non-standard steel ladder rungs (5)
- Grouting at manhole wall near pipe spalling
- Overall good/fair condition

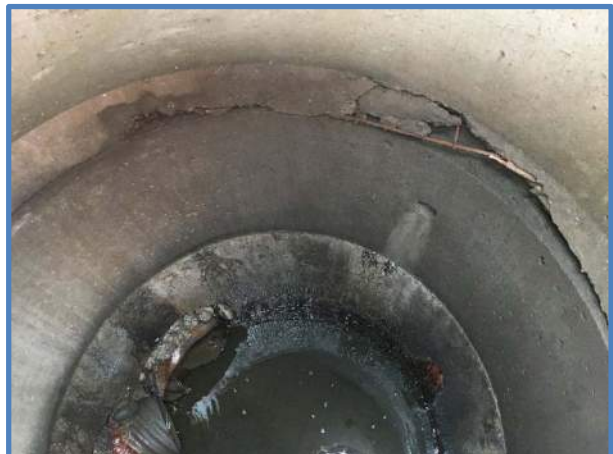
Photo 2 - Cone Damage, Exposed Steel

- Non-standard lid
- Minor offset between lid and grade rings
- Eccentric cone
- Steel ladder rungs (7)
- Barrel ok (2 sections), Inflow at bottom barrel joint
- Minor vertical cracking in grade rings
- Pipe penetrations show signs of spalling/degradation
- Rebar exposed at bottom of cone section (south side)

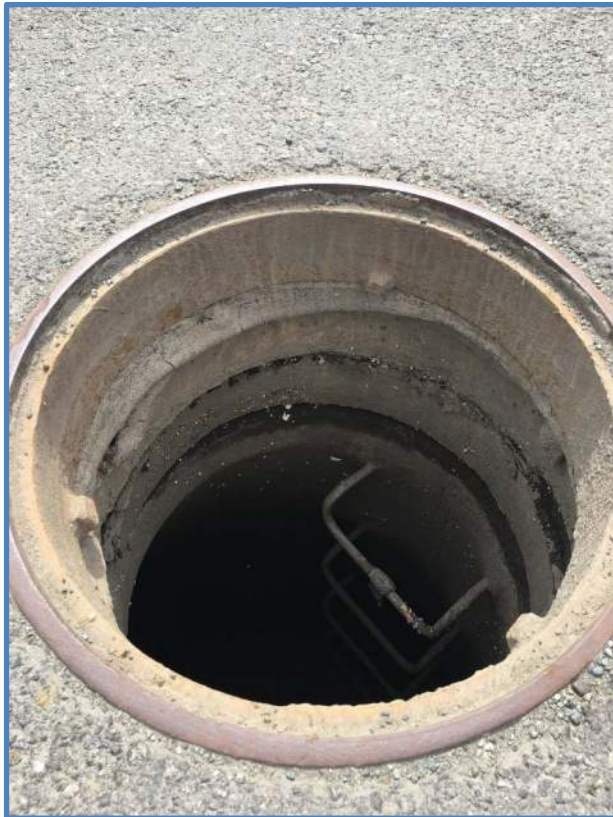
Photo 3 - Frame, Grade Rings & Ladder Rungs

- Non-standard lid
- Minor offset between lid, grade rings and frame
- Eccentric cone
- Steel ladder rungs (5)
- Barrel ok (2 sections), possible inflow at bottom barrel joint (appears damp)
- Grouting at manhole wall near pipe spalling

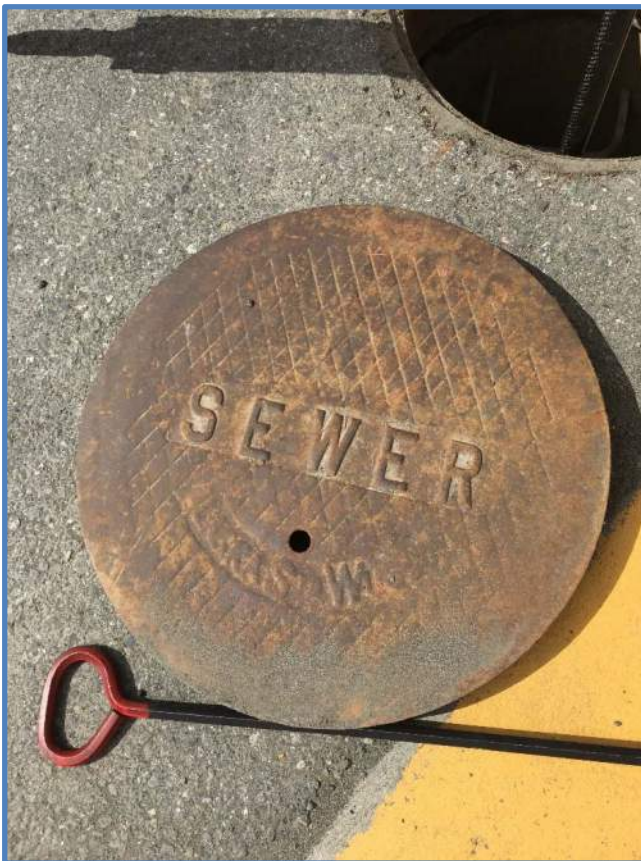
Photo 3 - Sewer Manhole Cover

- Non-standard lid – labeled “sewer”
- Eccentric cone
- Steel ladder rungs (6)
- Pipe penetrations appear to have been recently regouted
- Overall structure in good condition
