Storm Drain Condition Assessment Reports

Memorandum

Date: July 2, 2019
From: Marliese von Huene, P.E. & Joey Hegna, P.E. – CRW Engineering Group, LLC
Project: 48th Avenue and Cordova Street Reconstruction
Project No: PM&E# 06-26 (CRW# 10143.00)
Subject: CCTV Storm Drain Condition Assessment

Date: July 2, 2019
From: Marliese von Huene, P.E. & Joey Hegna, P.E. – CRW Engineering Group, LLC
Project: 48th Avenue and Cordova Street Reconstruction
Project No: PM&E# 06-26 (CRW# 10143.00)
Subject: Storm Drain Manhole Condition Assessment

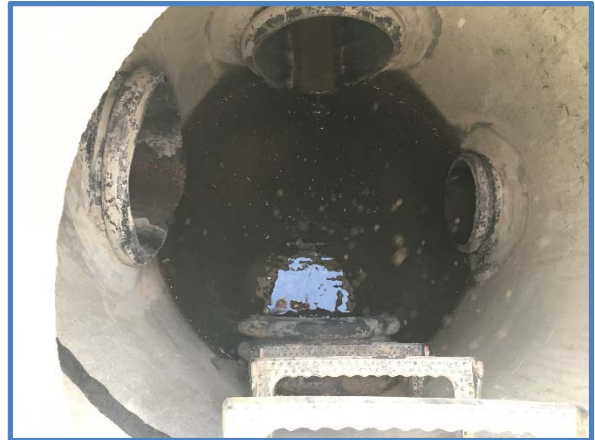
Photo 4 - Inlet & Outlet Pipe Penetrations

- Recently constructed
- Overall structure in good condition

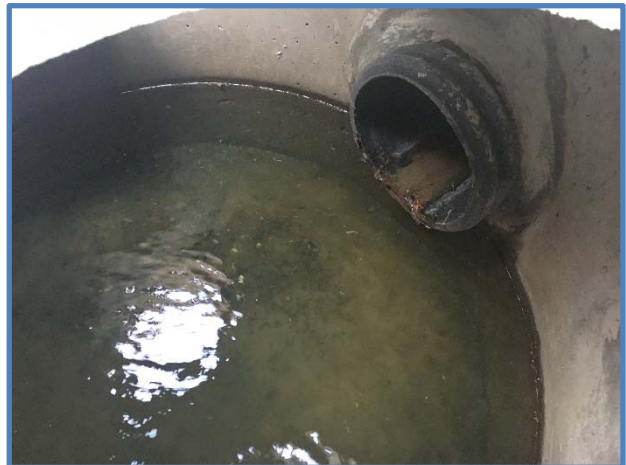
Photo 4 - Outlet Pipe Penetration

- Recently constructed
- 8-10" CPEP pipe coming from east is not shown on WMS mapping
- Overall structure in good condition

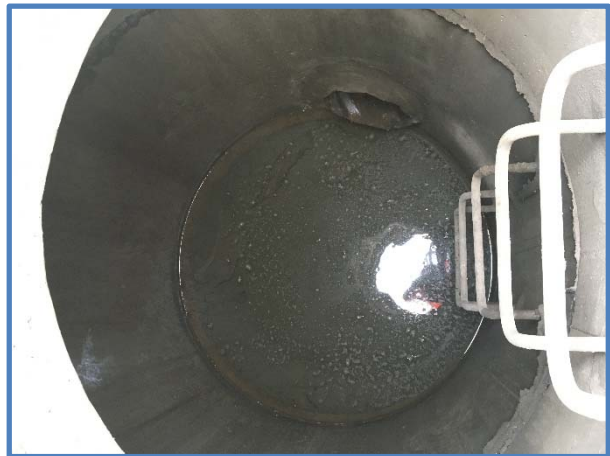
Photo 2 - Outlet Pipe Penetration

- Non-standard lid
- Minor offset between grade rings and frame
- Eccentric cone
- Non-standard steel ladder rungs (5)
- Grouting at manhole wall near pipe spalling
- Overall good/fair condition

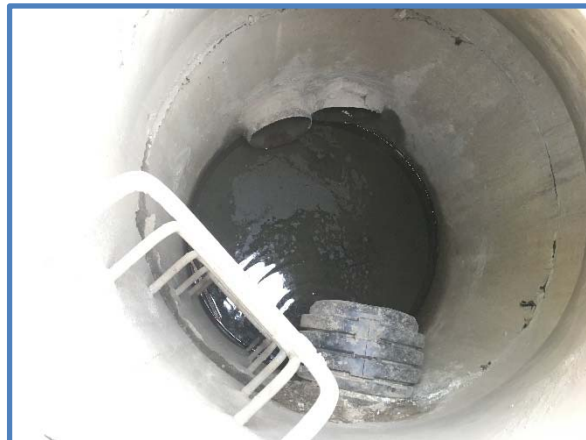
Photo 4 - Inlet & Outlet Pipe Penetrations / End Cap

- Non-standard lid
- Minor offset between cone and barrel, cone and grade rings, and grade rings and frame
- Eccentric cone
- Non-standard steel ladder rungs (6)
- South pipe has a CPEP cap over the end that is dripping, unsure of purpose

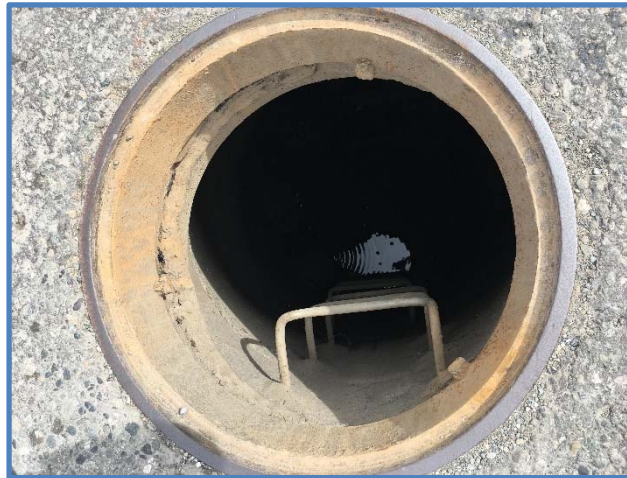
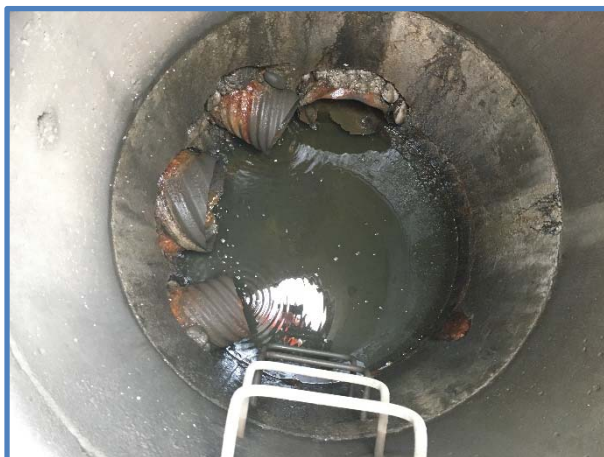
- Non-standard lid
- Minor offset between lid and grade rings
- Eccentric cone
- Steel ladder rungs (7)
- Barrel ok (2 sections), Inflow at bottom barrel joint
- Minor vertical cracking in grade rings
- Pipe penetrations show sings of spalling/degradation
- Rebar exposed at bottom of cone section (south side)

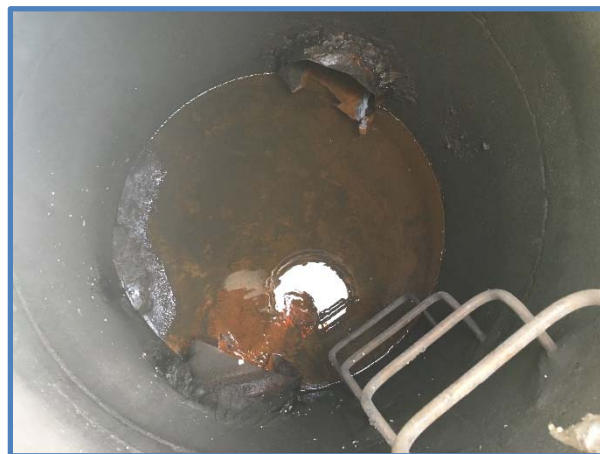
Photo 2 - Inlet & Outlet Pipe Penetrations

- Non-standard lid
- Minor offset between lid, grade rings and frame
- Eccentric cone
- Steel ladder rungs (5)
- Barrel ok (2 sections), possible inflow at bottom barrel joint (appears damp)
- Grouting at manhole wall near pipe spalling

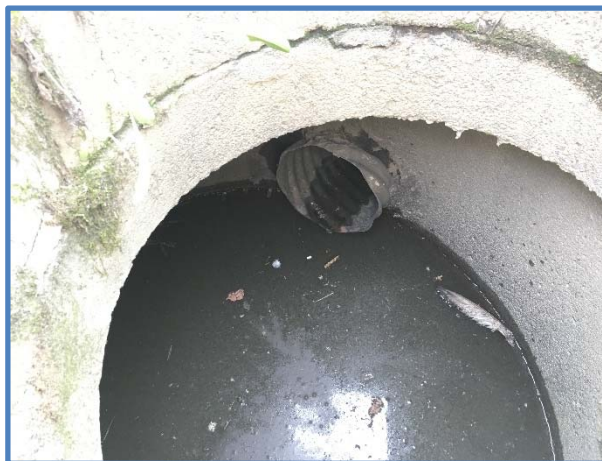
Photo 3 - Frame, Grade Rings & Reducing Slab

Photo 4 - Outlet Pipe Penetration

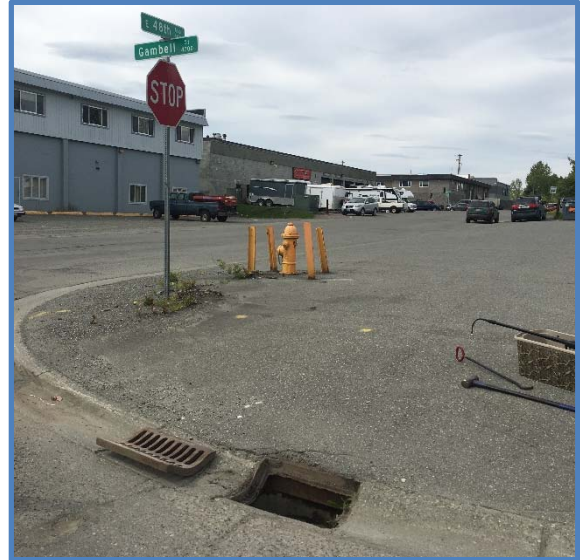
Photo 2 - Curb Inlet / Surrounding Area

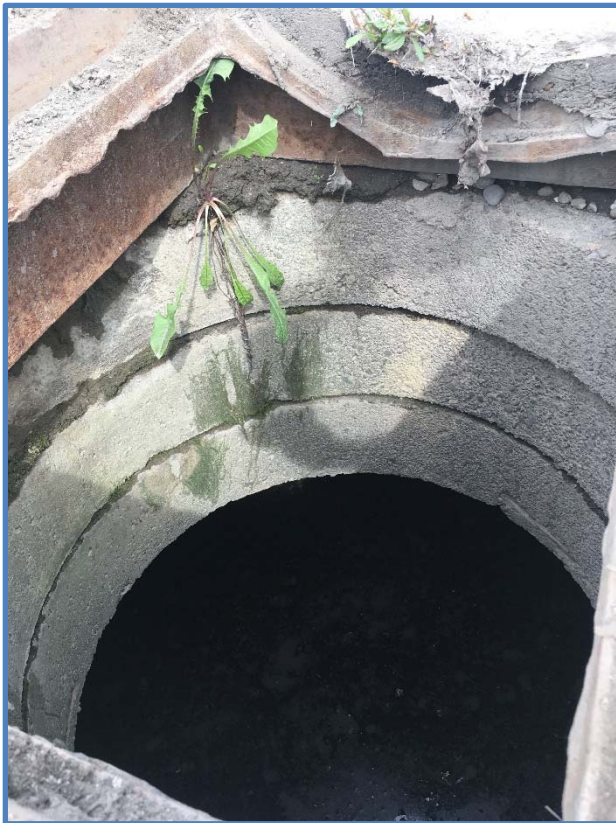
Photo 3 - Frame, Grade Rings & Reducing Slab

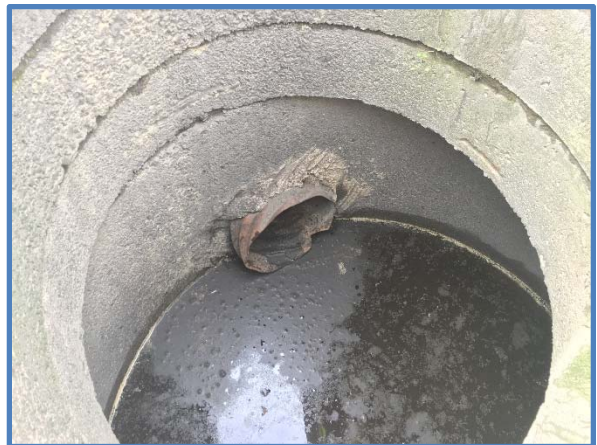
Photo 4 - Outlet Pipe Penetration
