Storm Drain Condition Assessment Reports

Date: July 2, 2019
From: Marliese von Huene, P.E. & Joey Hegna, P.E. – CRW Engineering Group, LLC
Project: 48th Avenue and Cordova Street Reconstruction
Project No: PM&E# 06-26 (CRW# 10143.00)
Subject: CCTV Storm Drain Condition Assessment

48th Avenue & Cordova Street Reconstruction CCTV
Area 1 - 48th Avenue and Cordova Street intersection

Date: July 2, 2019
From: Marliese von Huene, P.E. & Joey Hegna, P.E. – CRW Engineering Group, LLC
Project: 48th Avenue and Cordova Street Reconstruction
Project No: PM&E# 06-26 (CRW# 10143.00)
Subject: Storm Drain Manhole Condition Assessment

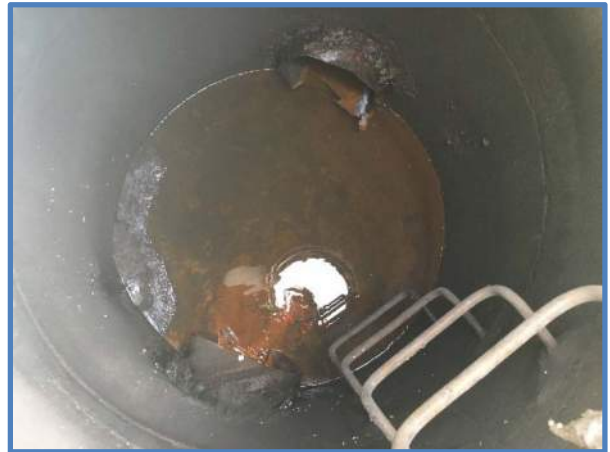
Photo 2 - Inlet & Outlet Pipe Penetrations

MANHOLE CONDITION NOTES:

- Non-standard lid – labeled “sewer”
- Eccentric cone
- Steel ladder rungs (6)
- Pipe penetrations appear to have been recently regouted
- Overall structure in good condition

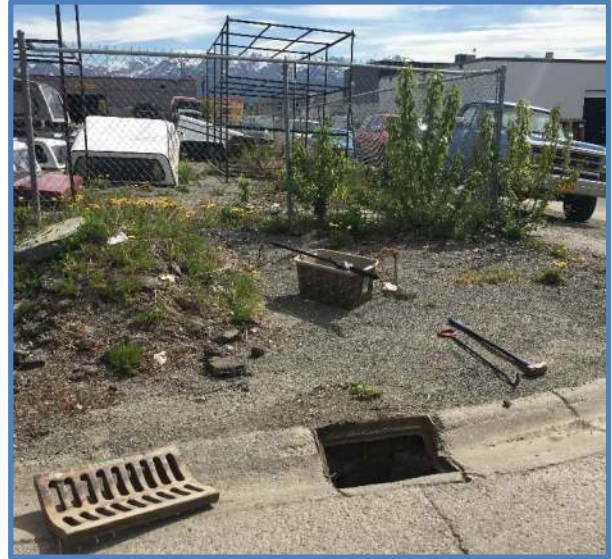
Photo 2 - Curb Inlet / Surrounding Area

- MANHOLE CONDITION NOTES:
- Type 2 curb inlet grate and frame
 - Overall structure in good/fair condition

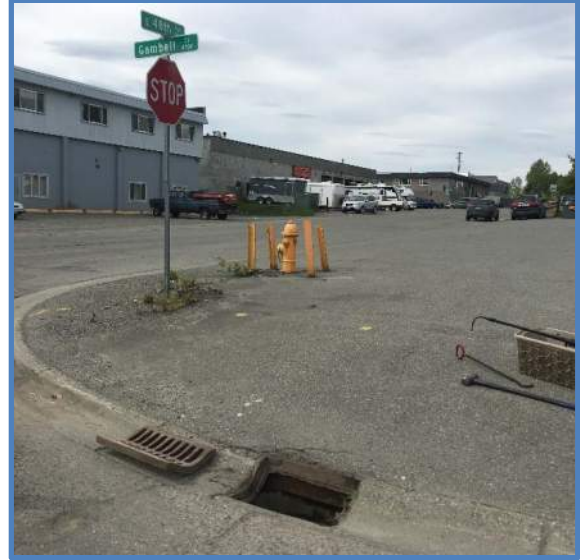
Photo 2 - Curb Inlet / Surrounding Area

- MANHOLE CONDITION NOTES:
- Type 2 curb inlet grate and frame
 - Overall structure in good/fair condition
