## 48th Avenue and Cordova Street Reconstruction

MOA PM&E No. 06-26

December 2019

# **Geotechnical Investigation 48<sup>th</sup> Avenue and Cordova Street Reconstruction (MOA PM&E Project No 06-26)**

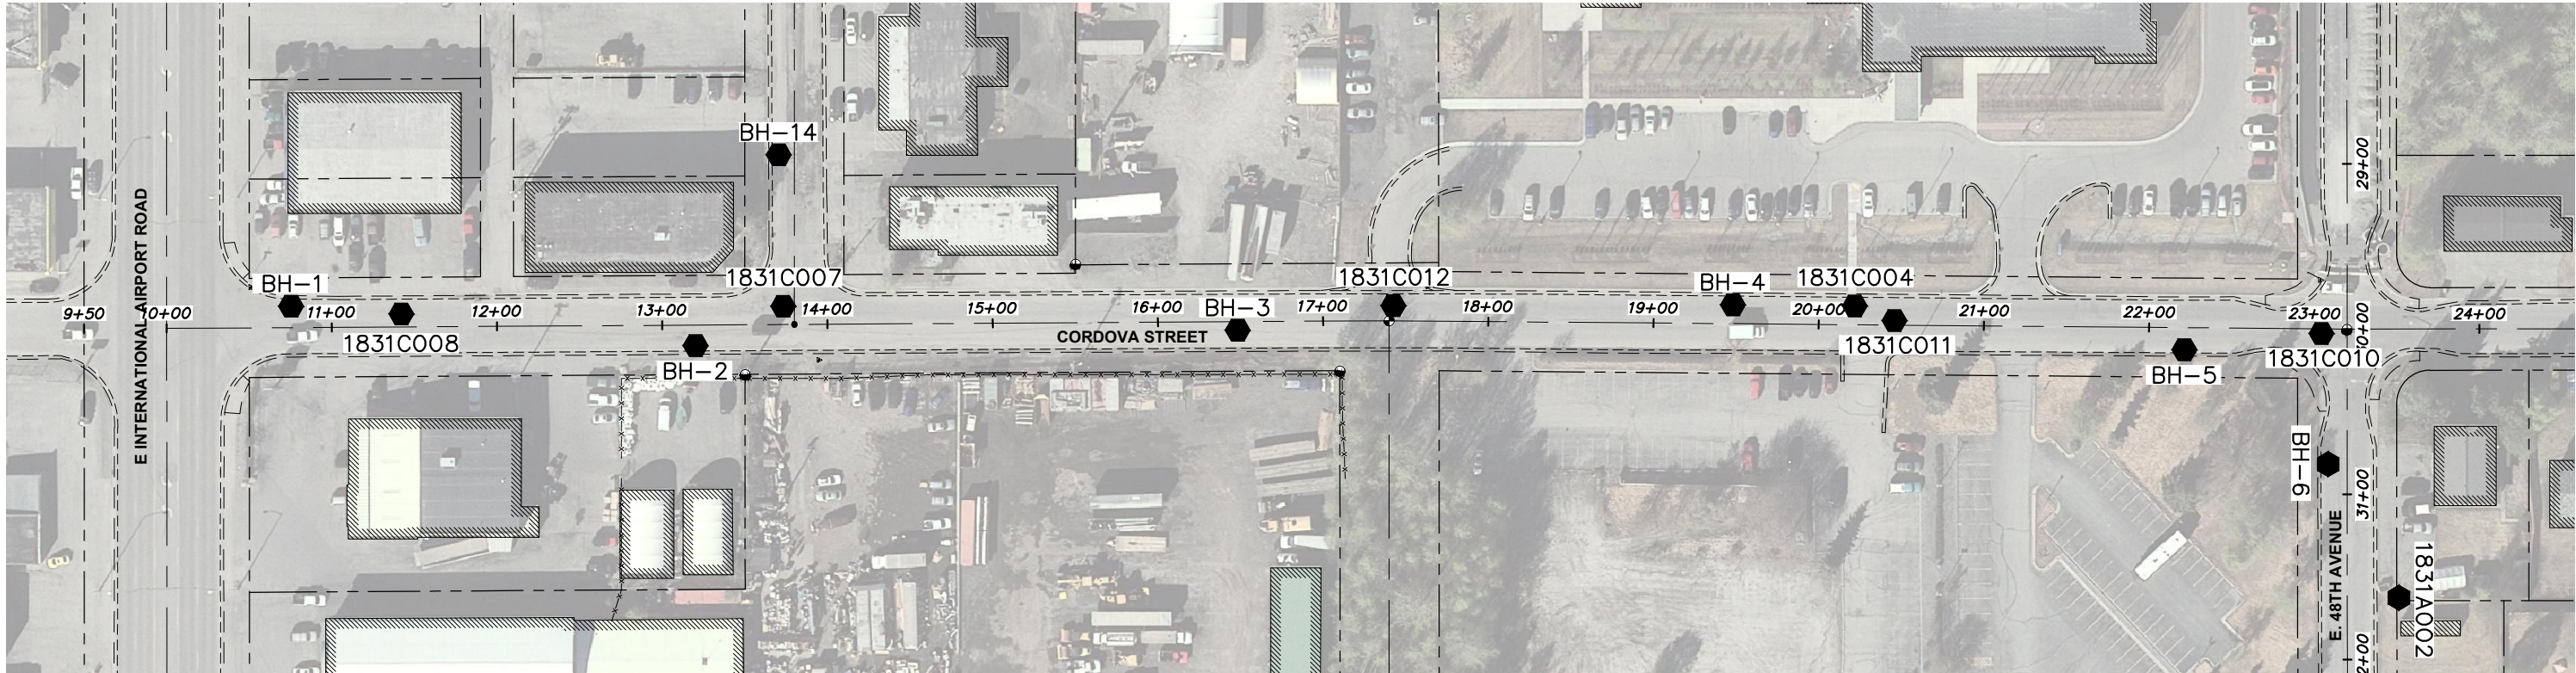
- BH-X  
● BOREHOLE LOCATION AND NUMBER
- 1831X00X  
● HISTORIC BOREHOLE LOCATION AND REFERENCE

Figure 1 – Vicinity Map
Figures 2 and 3 – Borehole Location Maps
Figure 4 – Typical Insulation Section with Center Subdrain

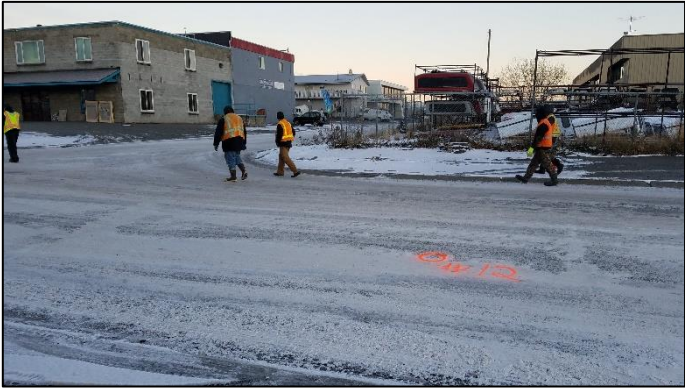
Marking of BH locations and utility locate meeting.

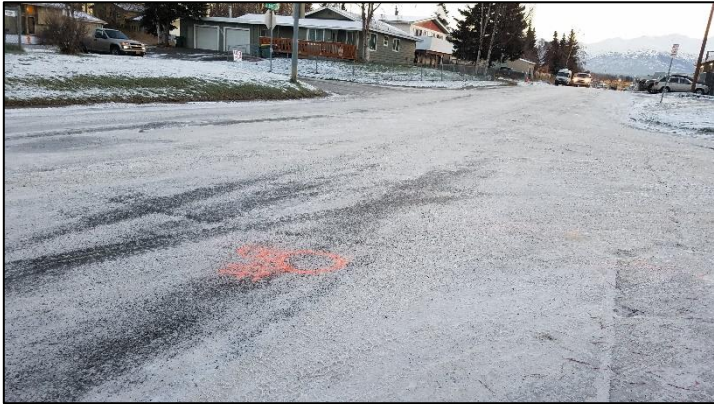
BH marking for BH-08.

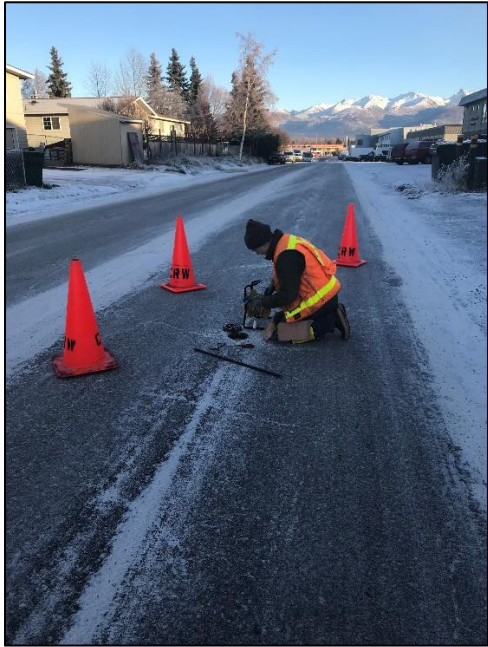
November 2018 water level measurements on 48 <sup>th</sup> Ave.
